CONCRETE CANVAS

AGRICULTURAL CASE STUDIES

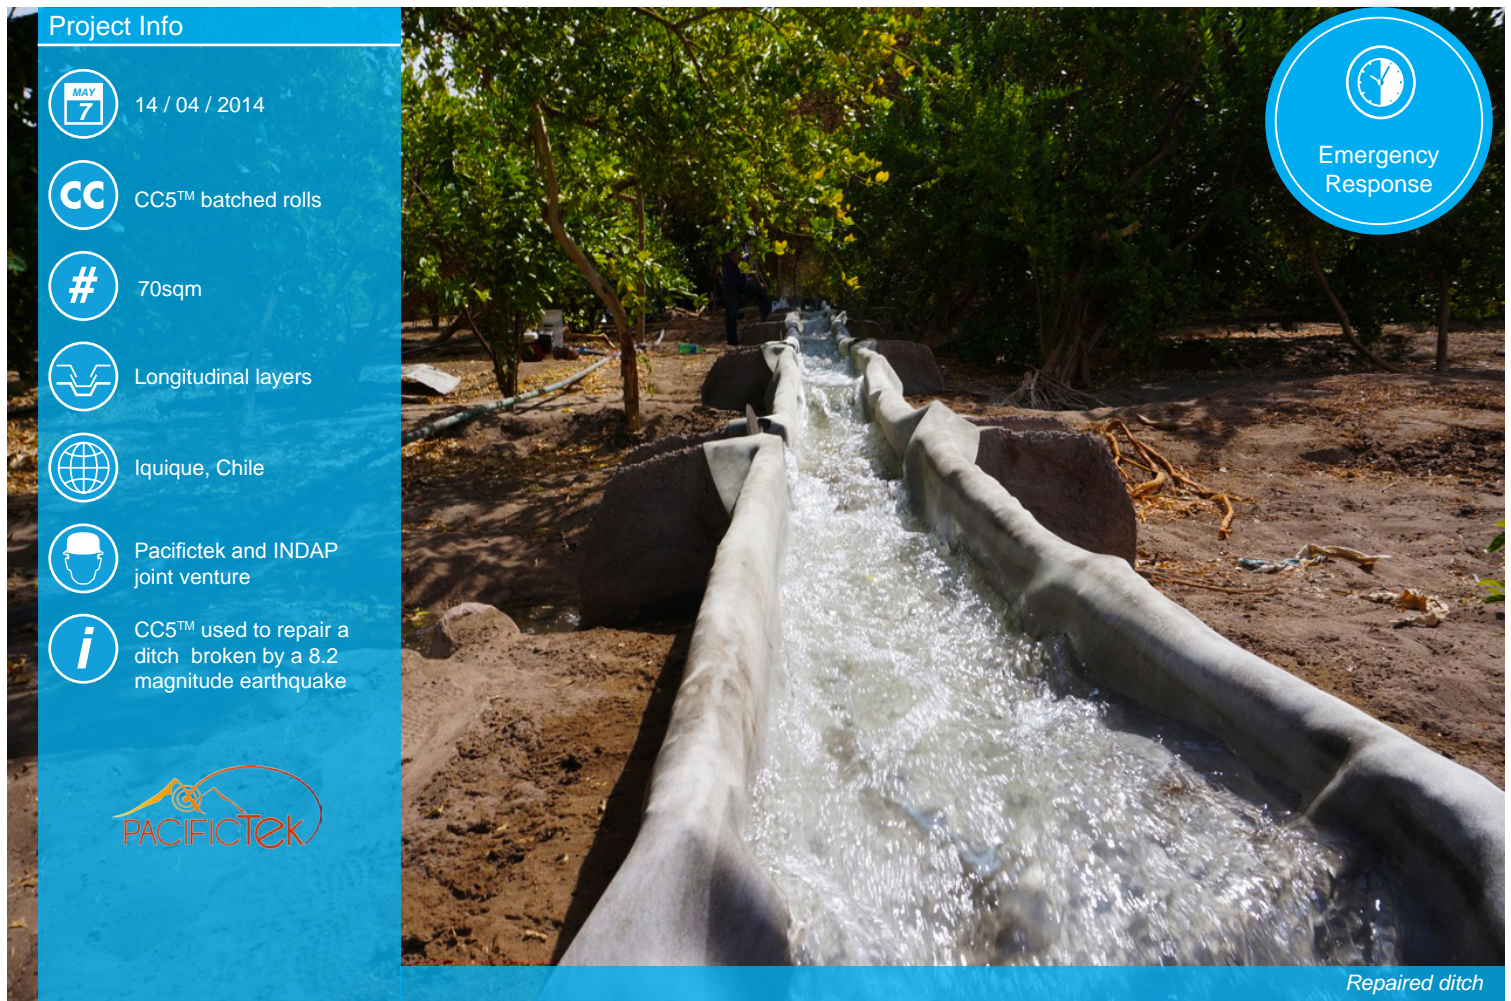
Repaired ditch

In April 2014 Concrete Canvas® GCCM* (CC) was used for emergency remediation of a concrete irrigation ditch at a lemon farm located in the small oasis town of Pica, 90km east of Iquique, Chile.

On the 1st of April 2014, a 8.2 magnitude earthquake struck off the coast of Chile, 95km northwest of Iquique. The force of the earthquake broke apart the farm's existing poured concrete irrigation ditch, cracking it in several places and making it unusable. This posed an immediate threat to the lemon trees and therefore the livelihood of the farmer. The INDAP (a government agency dedicated to help small farmers) and Pacifictek funded the project as a joint venture, both parties donating time, money and materials. The installation was completed by 3 INDAP personnel and a Pacifictek official.

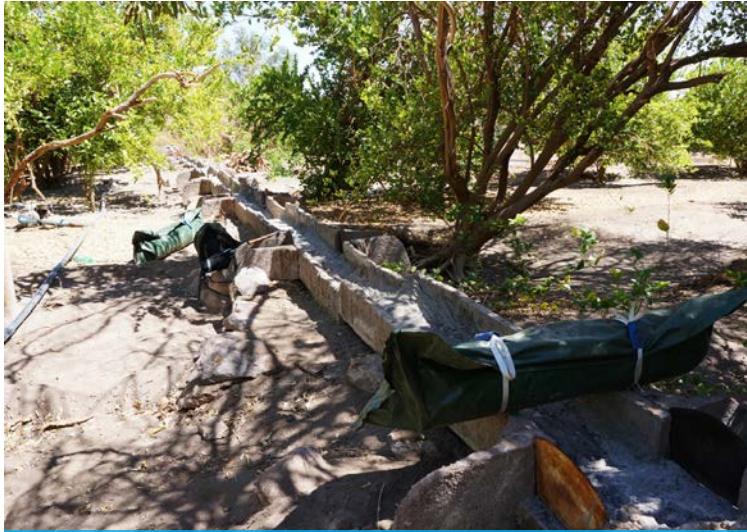
A batched roll of CC5™ and the broken ditch

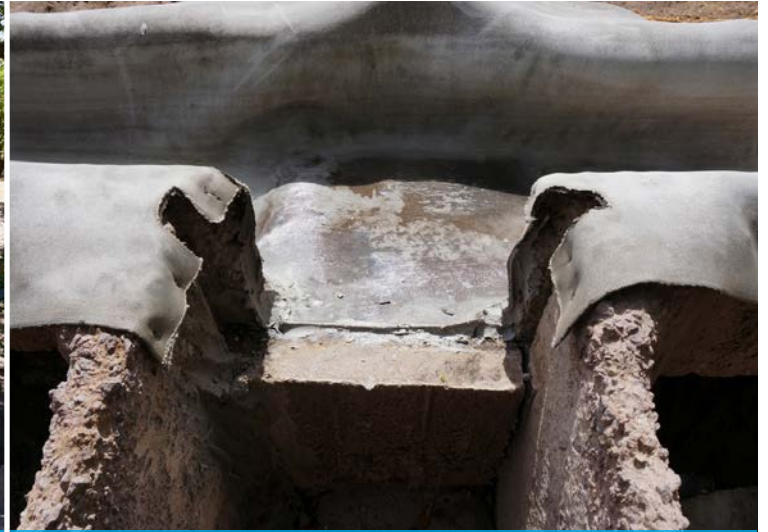
An epoxy grout joint to allow for the steel doors

Man portable 7-10sqm batched rolls of CC5™ were carried to site, as the proximity of the trees would not allow any kind of plant access. Loose stone and rubble were cleared from the ditch, before CC was unrolled down its length and folded over the existing structure. The CC was fixed to the poured concrete form using masonry screws at roughly 200mm centres. Each layer was overlapped by 100mm in the direction of water flow, screwed and grouted with an epoxy grout. Epoxy grout was also used on the joints created by the steel doors located on the sides of the ditch, which are opened to allow irrigation.

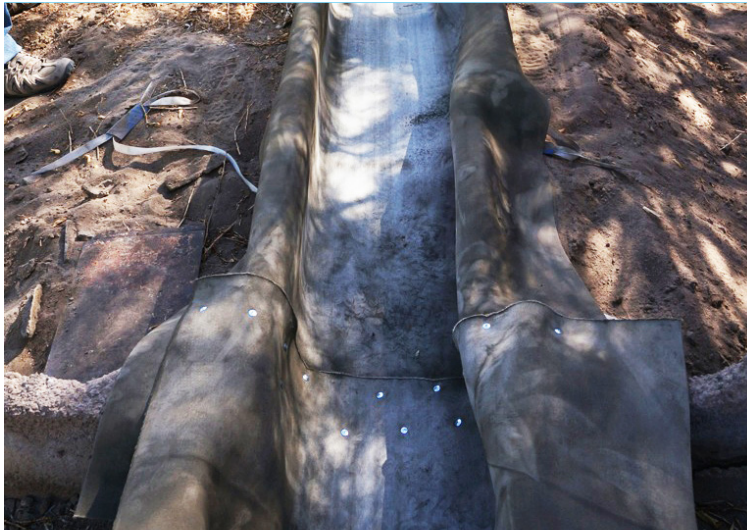
Overlapped and screwed joint

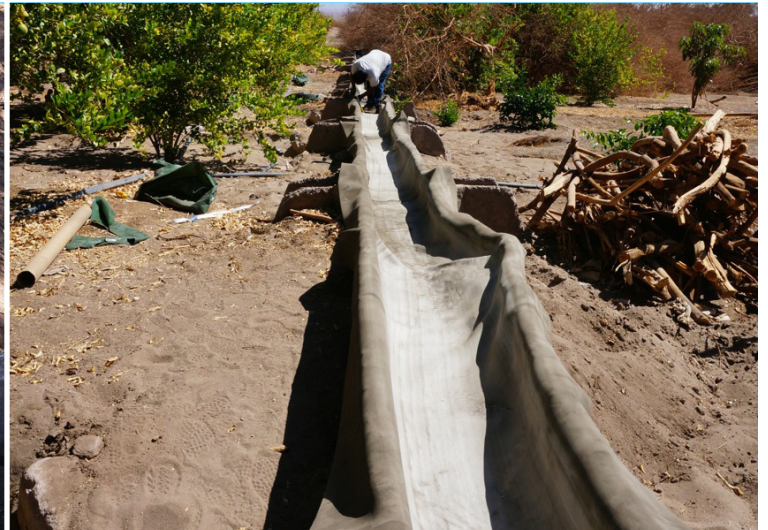
Example of CC conforming to profile

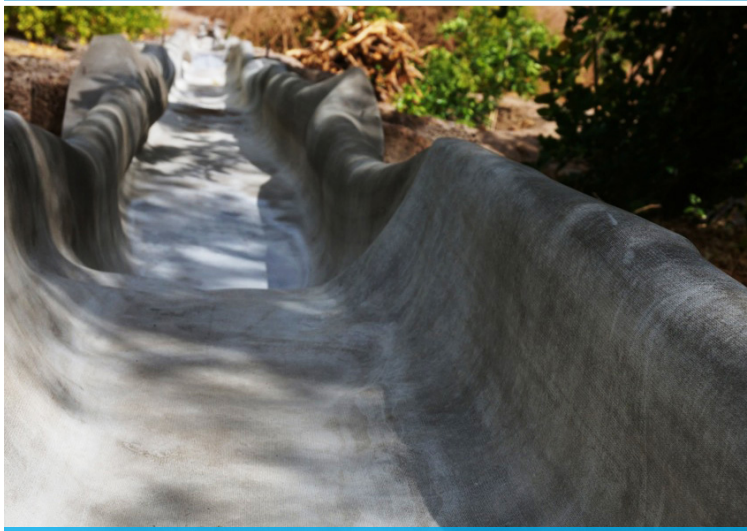
After hydration

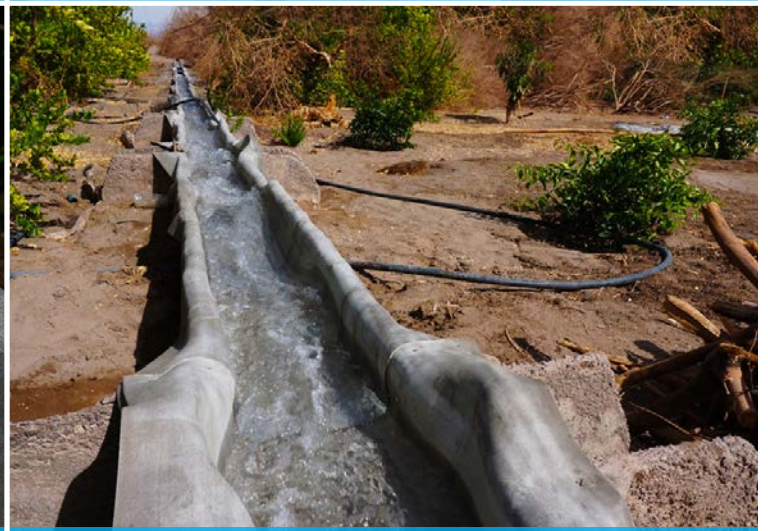
The finished ditch

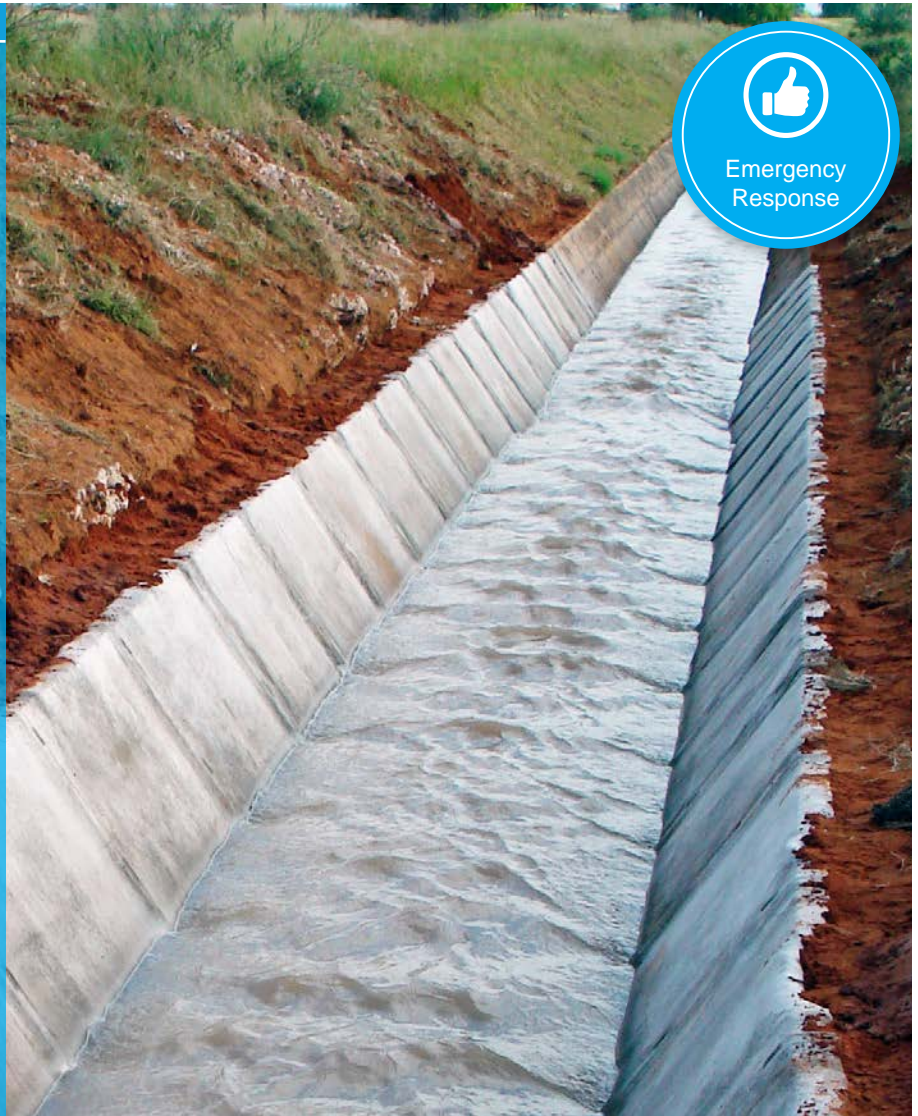
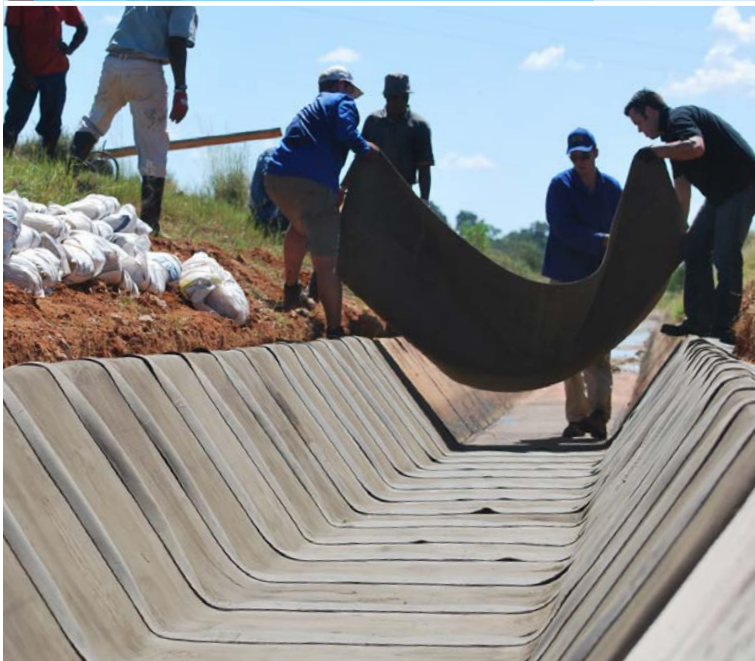
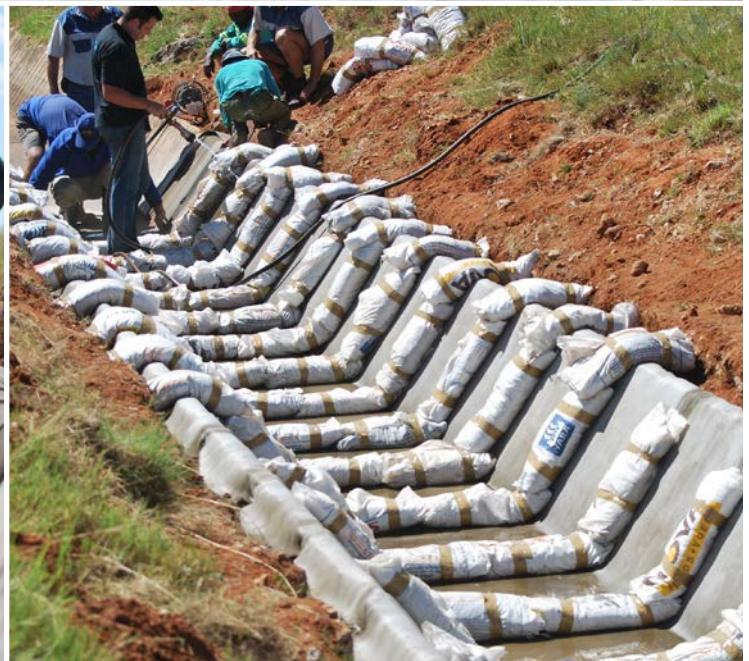
The objective of this trial was to establish whether CC could be used to reline existing canals that have deteriorated and need either localised repair work or need to be completely relined. The profile of this canal measured approximately 2.9m in laid width. A 'surface-to-surface' bonding technique, where the material is folded back on itself by 50mm so that there is CC to CC contact was used for the securing the joints with the overlap in the direction of water flow. The trial was completed within 3 hours and the result is a durable, efficient and neat section of canal that was relined with relative ease and at a very good rate of implementation. The joints proved to be very strong and rigid which results in a new relined section of the canal that is completely waterproof.

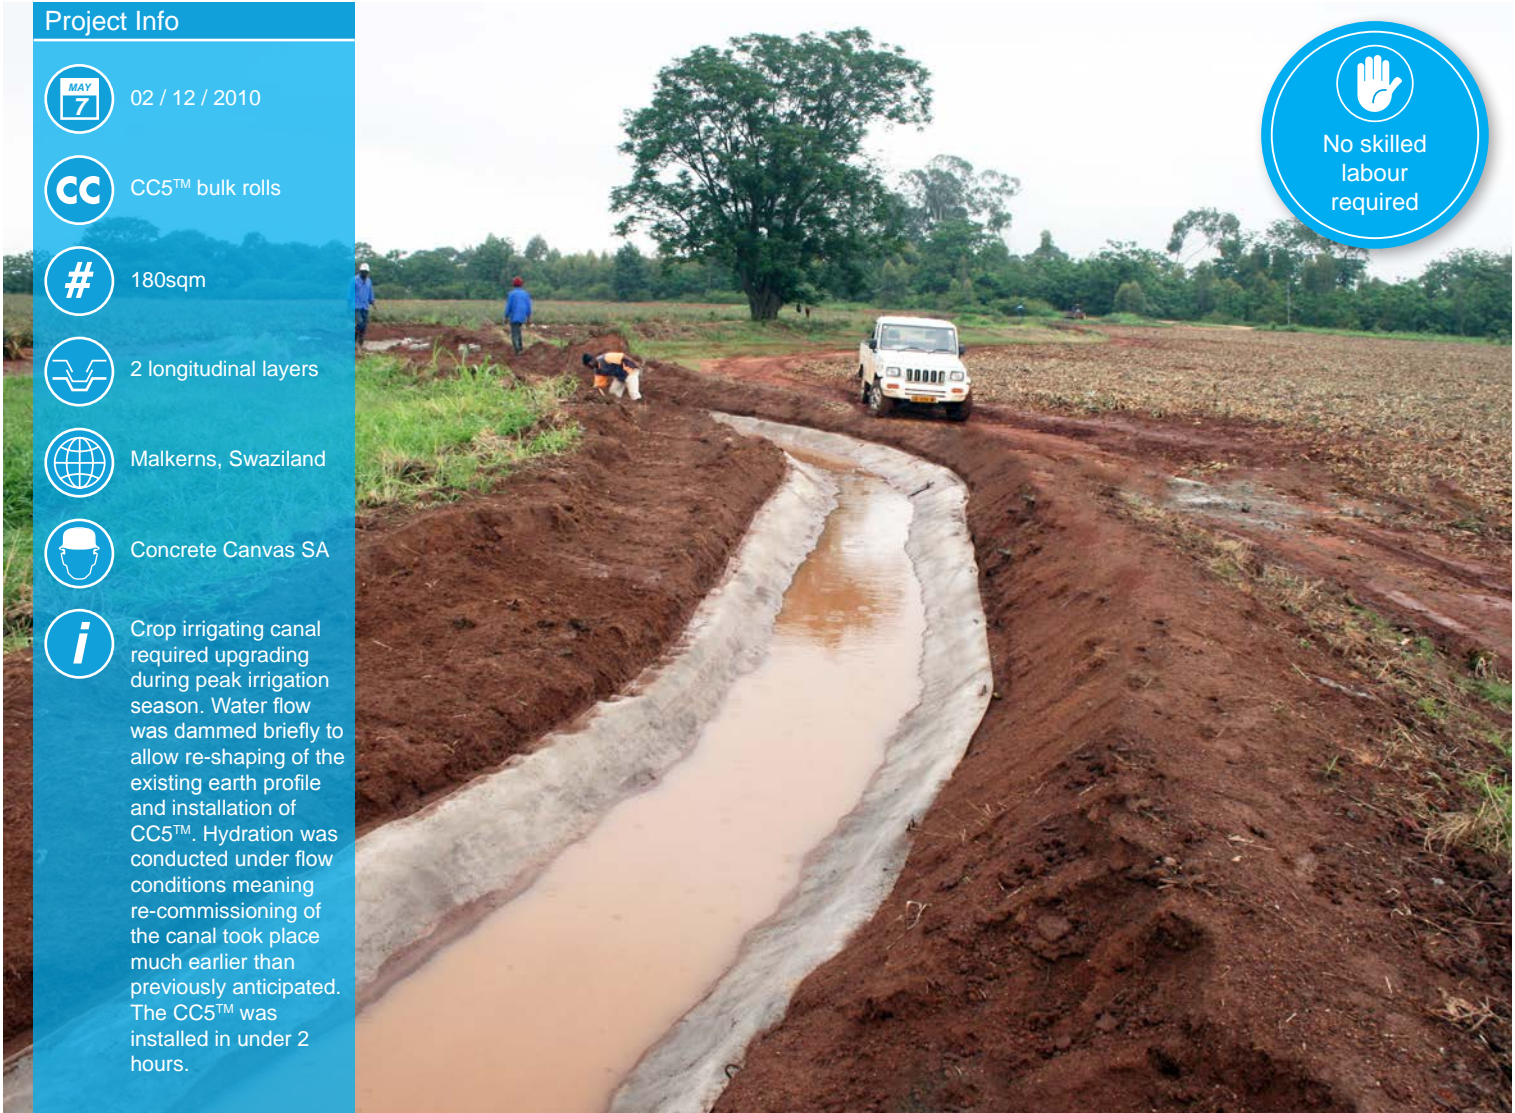
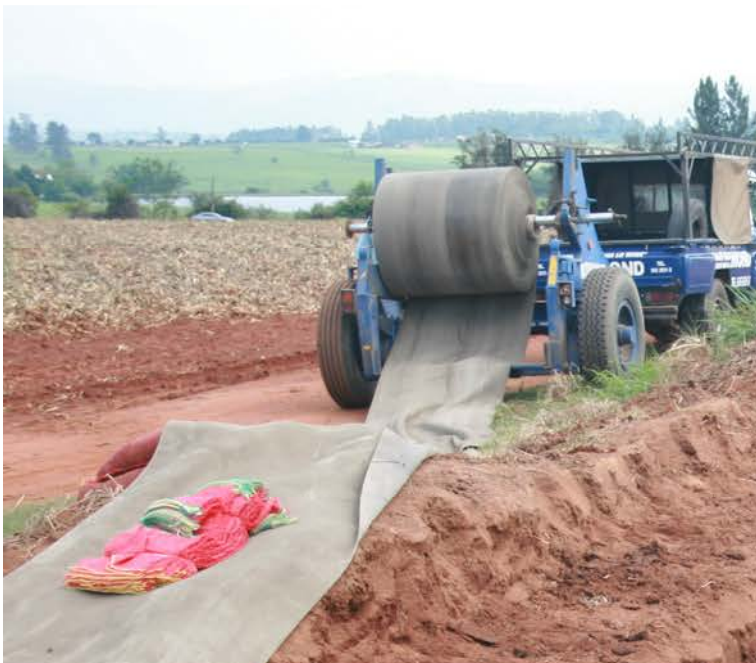
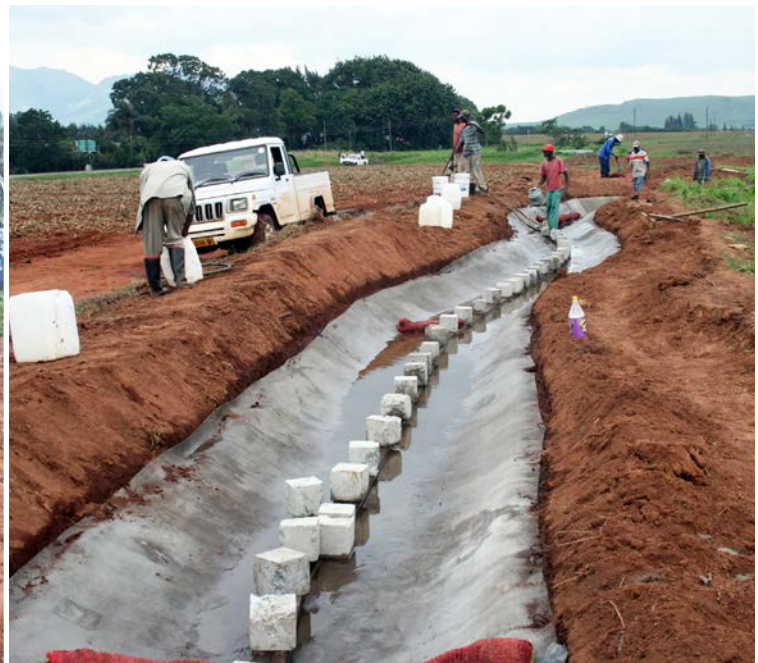
Crop irrigating canal required upgrading during peak irrigation season. Water flow was dammed briefly to allow re-shaping of the existing earth profile and installation of CC5™. Hydration was conducted under flow conditions meaning re-commissioning of the canal took place much earlier than previously anticipated. The CC5™ was installed in under 2 hours.

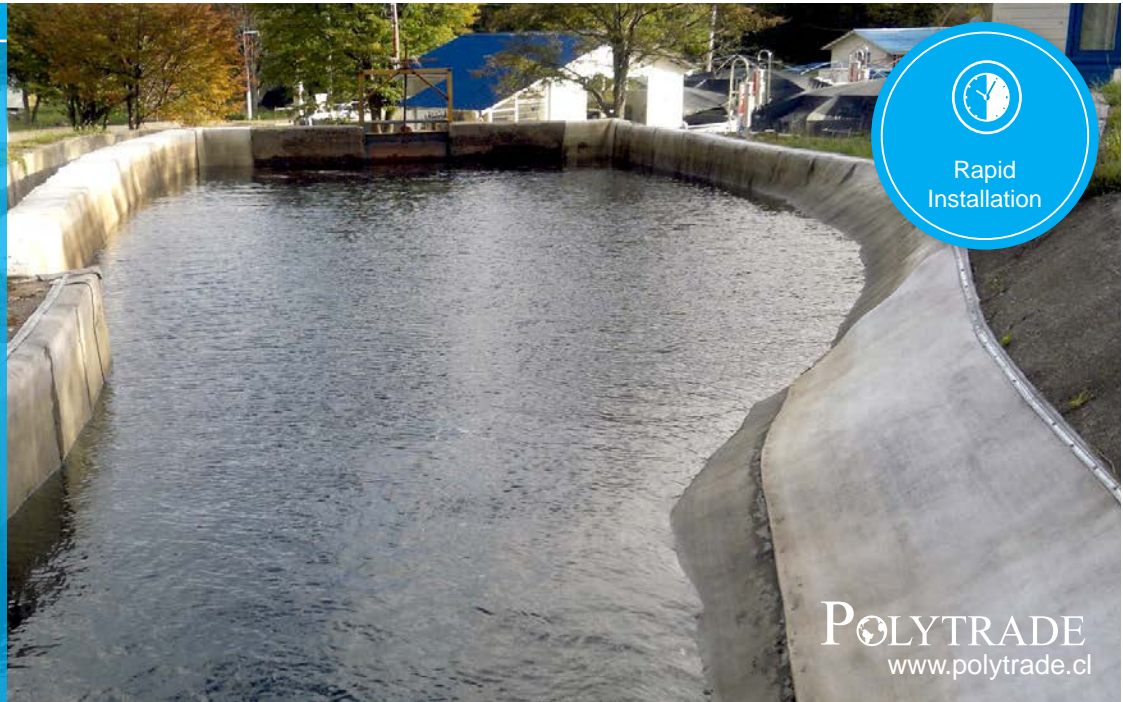
Reconditioned fish farm reservoir which was restocked 1 day after CC installation

CC used for time critical remedial work of a fish farm, lining a cracked and dilapidated concrete reservoir.

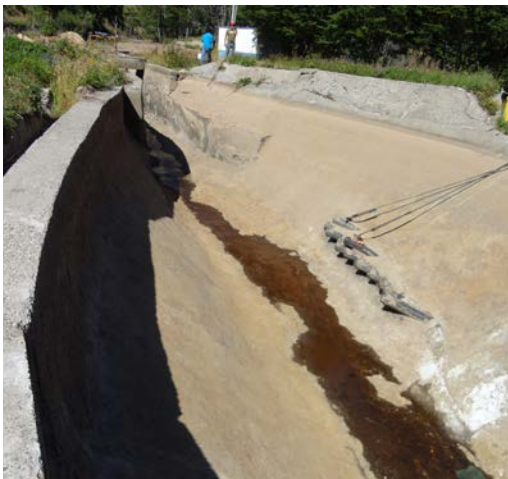
Dilapidated concrete reservoir

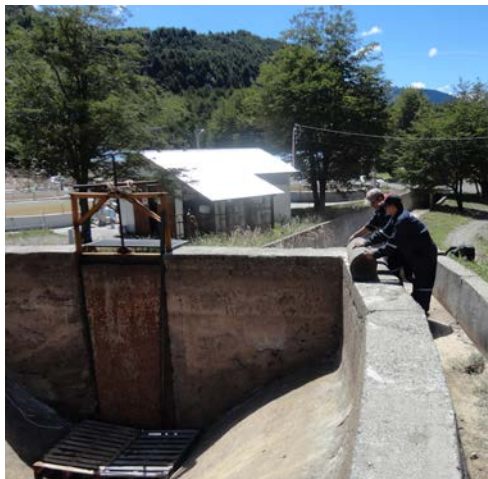
Unrolling CC8™ batched rolls into position

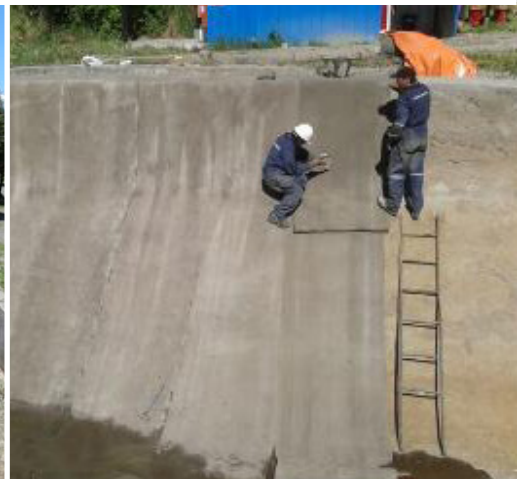
Fixing CC to the existing concrete substructure

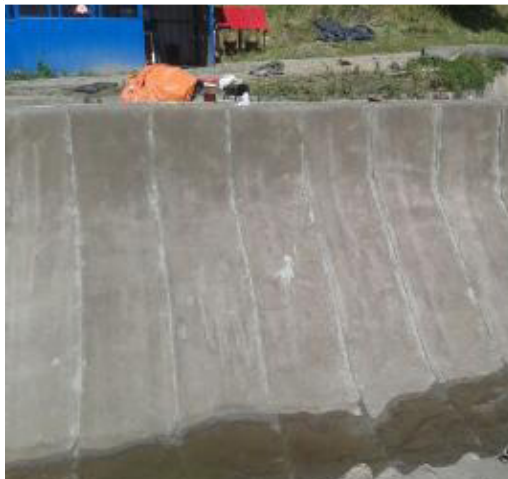
Lined concrete reservoir with sealed joints

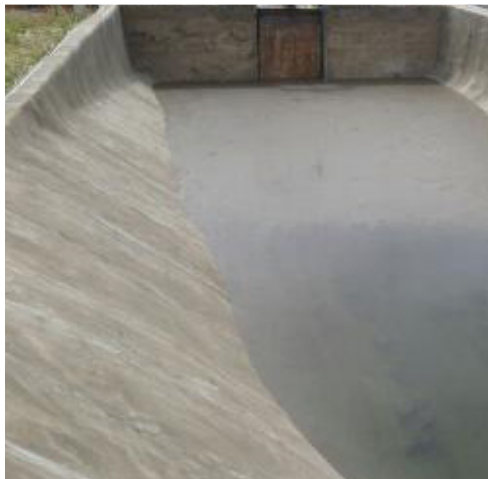
Refilling the basin to hydrate the CC

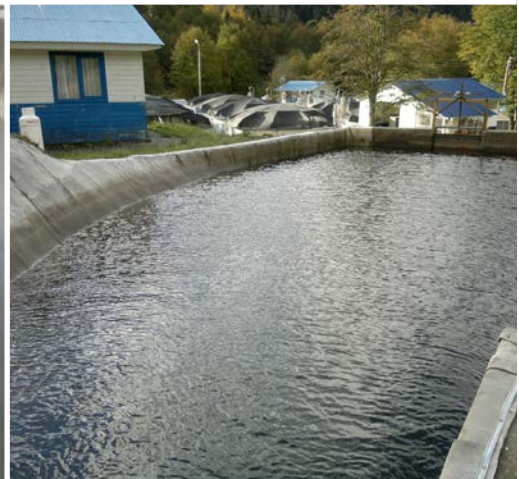
Completed reconditioned fish reservoir

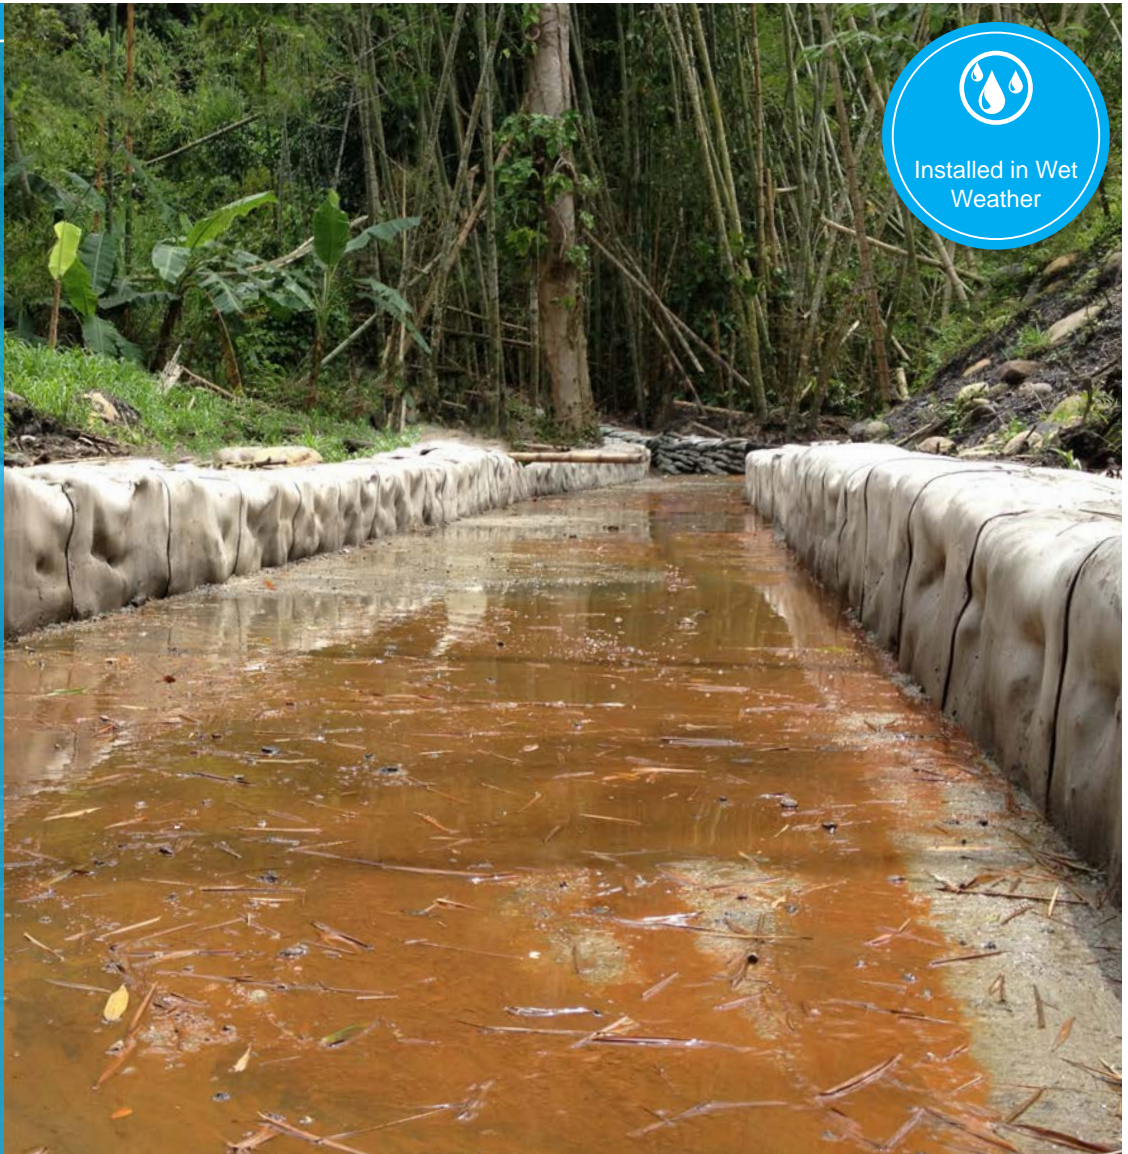
Completed CC lined ditch section, Nocaima, Cundinamarca, Colombia

CC was used to line a sandbag and gravel bed ditch designed to prevent ground saturation of nearby private properties in a remote jungle area.

The installation was completed in 4 days using a team of 5 workers. Limited site access and inclement weather prohibited more traditional concrete solutions so CC was specified as an environmentally friendly high performance liner to prevent erosion of the sandbag wall structures.

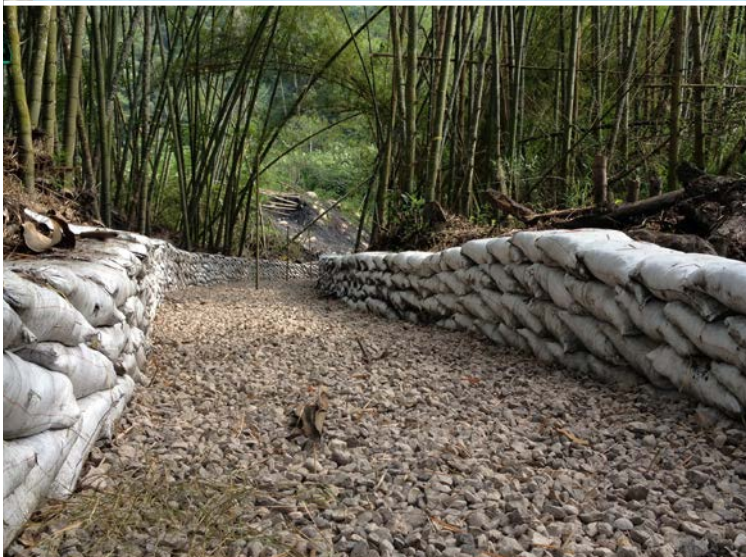
Ditch profile prior to lining with CC

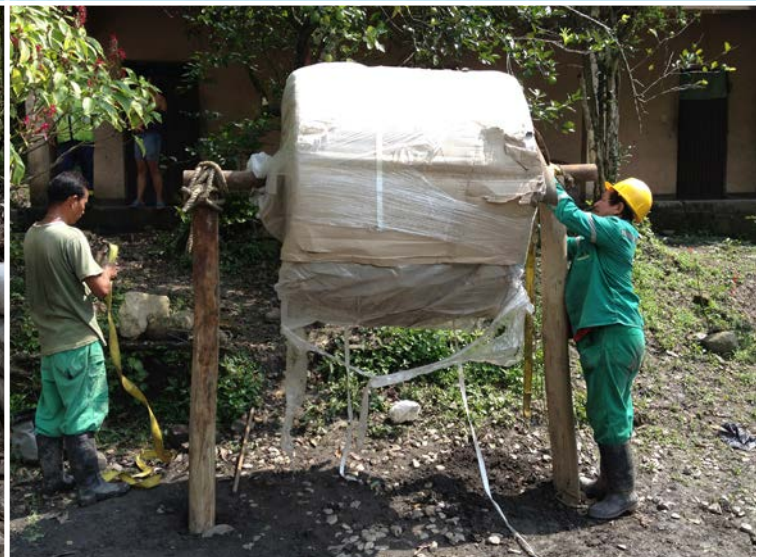
CC dispensed from a bulk roll on site before being cut to length

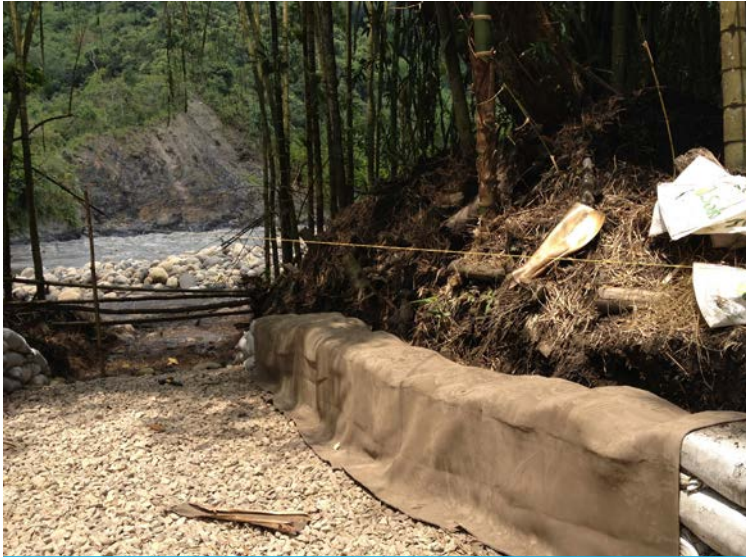
CC pre-cut sections of 1.5m positioned over sandbag wall prior to fixing

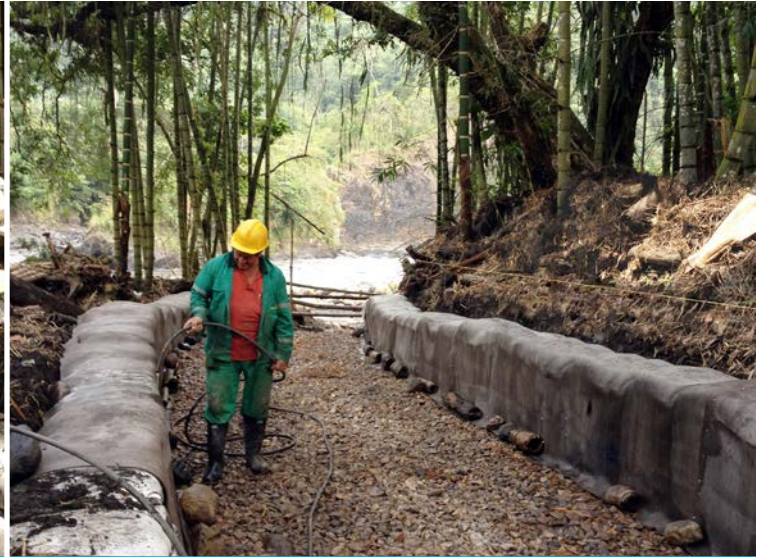
Hydration of the CC layers using local water source

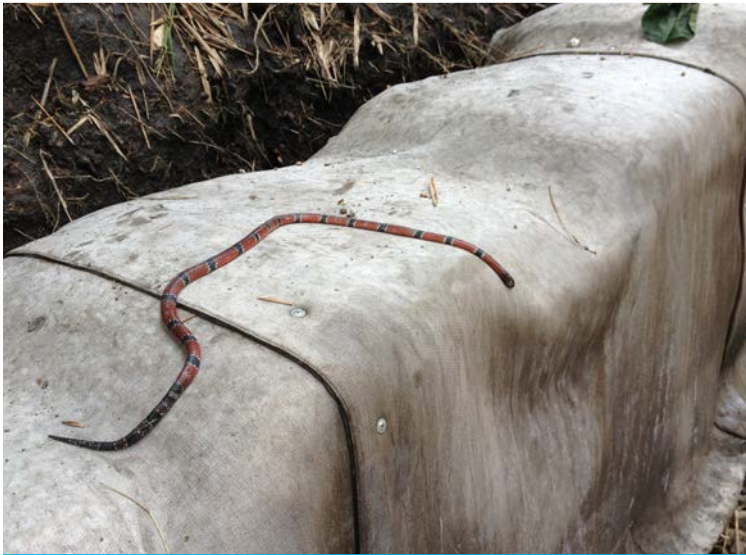
Adjacent CC layers were overlapped and screwed together

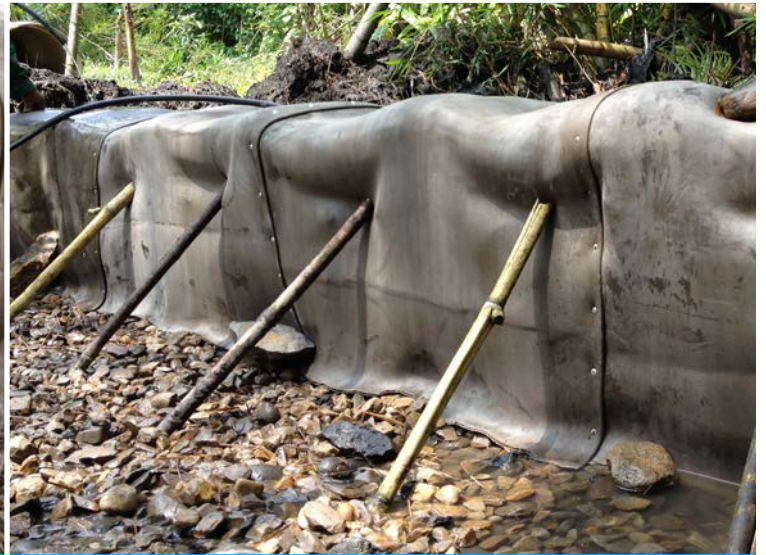
Wooden beams were used to close voids immediately after hydration

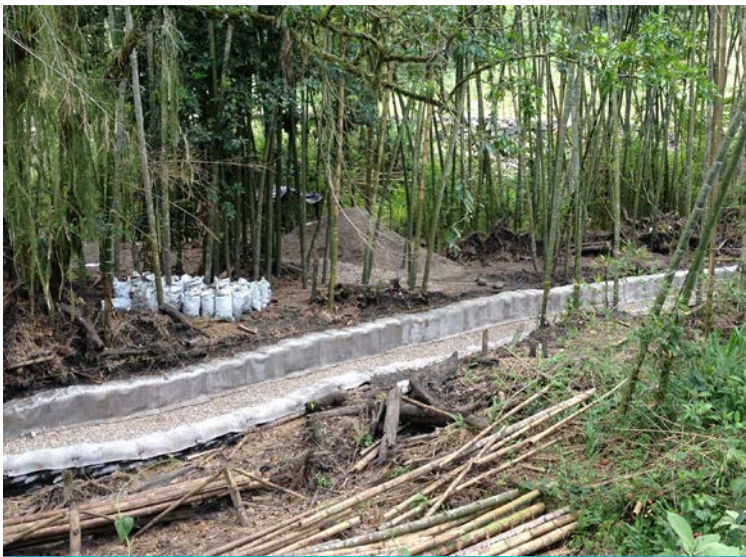
CC was applied to both sides of the 80 linear metre long ditch

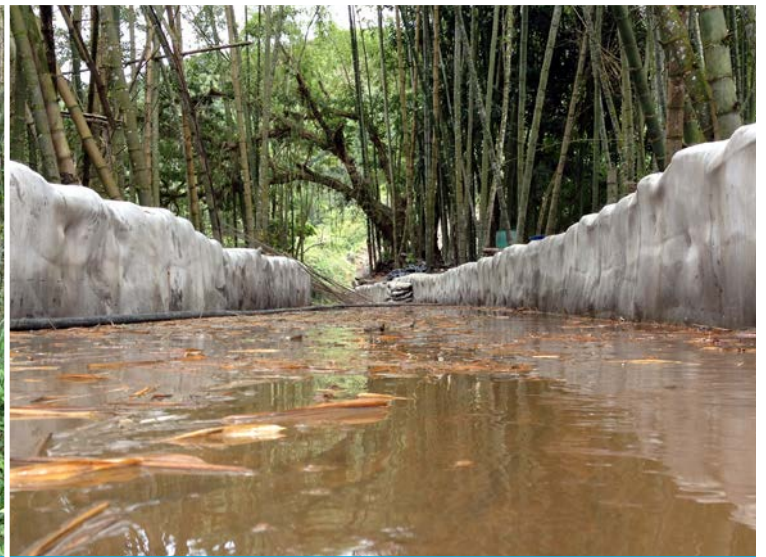
Completed CC lined ditch with redirected water flow
