© CONCRETECANVAS PETROCHEM CASE STUDIES

Concrete Canvas® is a Geosynthetic Cementitious Composite Mat (GCCM), part of a revolutionary new class of construction materials. It is a flexible, concrete impregnated fabric that hardens on hydration to form a thin, durable, water proof and fire resistant concrete layer. Essentially, it's concrete on a roll. Concrete Canvas® GCCM (CC) is predominantly used for erosion control applications such as bund lining, ditch lining, slope protection and the lining of tertiary containment lagoons.

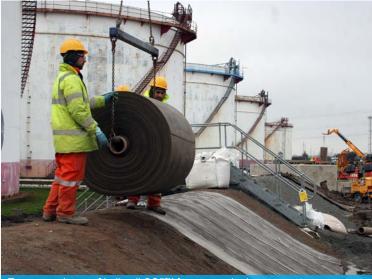
Transverse layup of bulk roll CC5™ from spreader beam

The 25,500sqm of CC was supplied in called off staggered deliveries to minimise on-site storage of material and to provide flexibility to the programme of works according to the weather conditions. Following refurbishment of the clay bunds, bulk rolls of 200sqm of CC5™ were dispensed onto the bunds from a chain hoisted spreader beam mounted from a 13T tracked excavator. Each CC5™ bulk roll was positioned at the crest of the bund, before unrolling the required length down the inside. The bulk roll was then unrolled down the outside edge before being cut to length using utility knives.

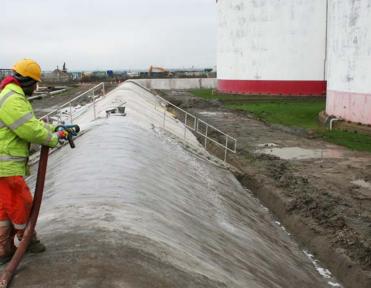
Hydration of CC from on site mains water supply

Subsequent layers of CC were positioned to overlap the previous by 100mm. Once each section of bund had been lined, the CC was hydrated using a fire hose from the nearby water mains. Following hydration, the overlapped edge was then folded back on itself by approximately 50mm to apply CT1 sealant in a continuous 5mm bead along the length using a 600ml applicator sealant gun. The CC edge was then folded back and screwed in position using 30mm screws applied with an auto-fed collated screw driver. The sealant created an impermeable joint whilst the screws provided the mechanical bond between overlapped CC layers. Each layer was anchor trenched at both inside and outside edges of the bund. At approximately 24 hours from the point of hydration, the CC had set to 80% strength and was able to be trafficked as works continued on installing kerb work and drainage details on the inside of the bund.

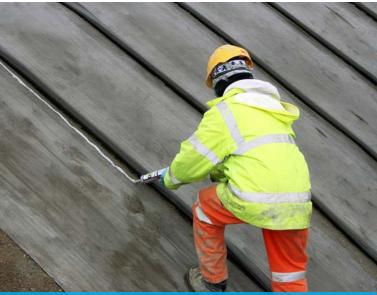
Adhesive sealing of 100mm overlapped joints using CT1

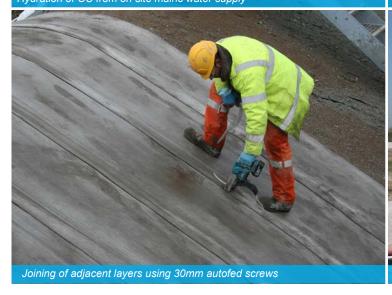
Completed section

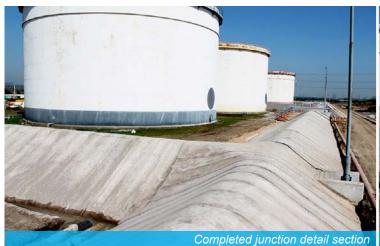
TERMINATION OF CONCRETE CANVAS TO CONCRETE HEADWALL / BUTTRESS

Buttress wall fixing

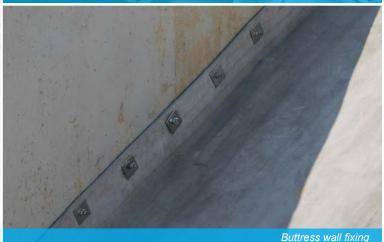
TERMINATION OF CONCRETE CANVAS
TO POLYMER HEADWALL / BUTTRESS

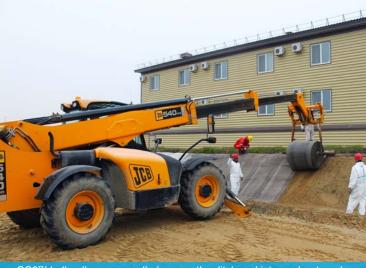
CC8™ bulk rolls were unrolled across the ditch and into anchor trenches

The ditch was re-graded using an excavator, vegetation removed and an anchor trench cut on either shoulder. A transverse layup was chosen due to the varying profile of the ditch. A Zoom Boom and spreader bar combination was used to lift 8mm thick CC (CC8™) bulk rolls and manoeuvre them into position, either to be unrolled from the crest of the ditch or so they could be unrolled on the flat. The CC8™ was then cut to specific profile lengths using a utility knife, eliminating any wastage. The installation team ensured there was a 100mm overlap in the direction of water flow between the layers of CC8™ before fixing it to the substrate with 375mm J-pegs. The overlaps were then sealed with Dow Corning 762 sealant and screwed at 200mm centres with 30mm coated screws, before being hydrated with a pressure hose and 7000 litre bowser.

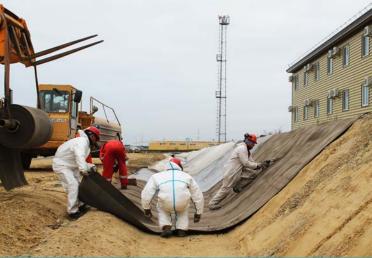
Unset CC8™ cut to length, avoiding wastage

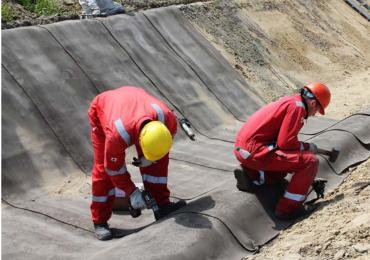
CC8™ sealed, screwed and fixed to the substrate with ground pegs
