CONCRETE CANVAS

OUTFALL CASE STUDIES

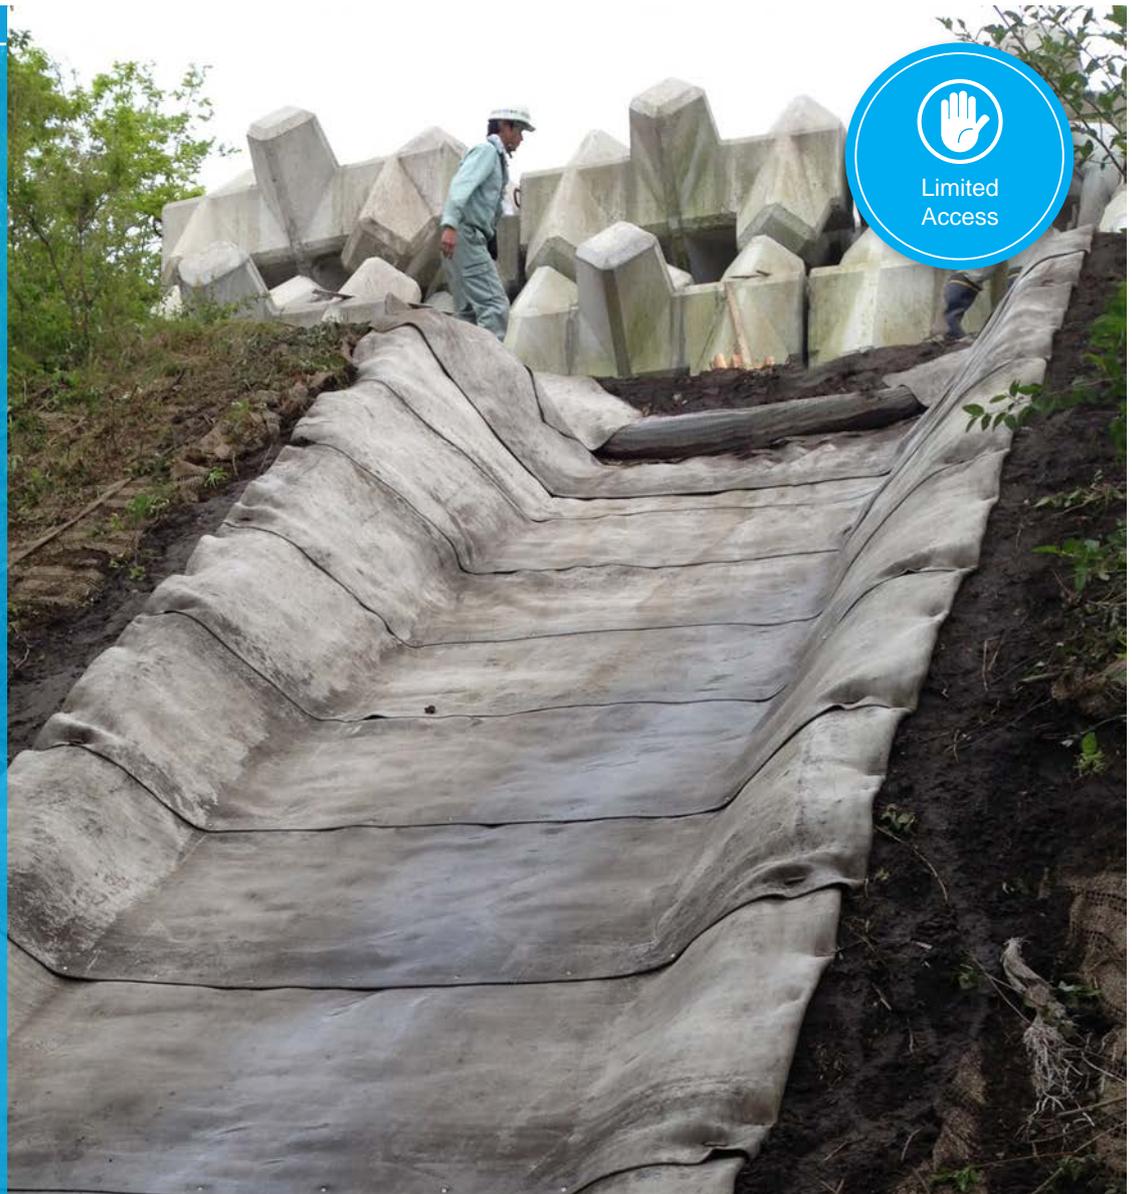
Completed installation

In June 2014, Concrete Canvas® GCCM* (CC) was used to line an outfall at the base of Mt Asama in Naganohara-town, Gunma-Prefecture, Japan. The CC was installed by Watanabe Kensetsu Co. for the Ministry of Land, Infrastructure, Transport and Tourism (MLIT). The outfall was causing large amounts of soil erosion and the water was penetrating the slope, risking slip. In-situ concrete was considered, however with limited site access it would have been difficult getting the raw material to site. Additionally in-situ concrete would have taken much longer and works would have been halted by inclement weather.

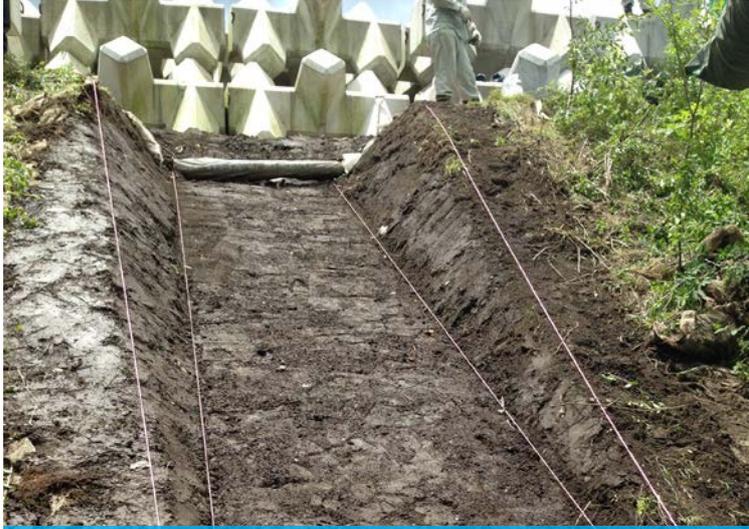
Ground preparation

The ground was compacted and any areas of deep erosion were filled to prevent any voids under the CC. The outfall was then profiled by hand and batched rolls of 5mm thick CC (CC5™) were delivered to site. The CC layers were manoeuvred into place by the labourers, who ensured each layer overlapped the previous by 100mm. Each CC layer was pegged at the crest and the overlaps were screwed at 200mm centres. The edge of each CC layer was folded back underneath itself to provide a neat termination. Hydration was achieved using a hose and bowser combination.

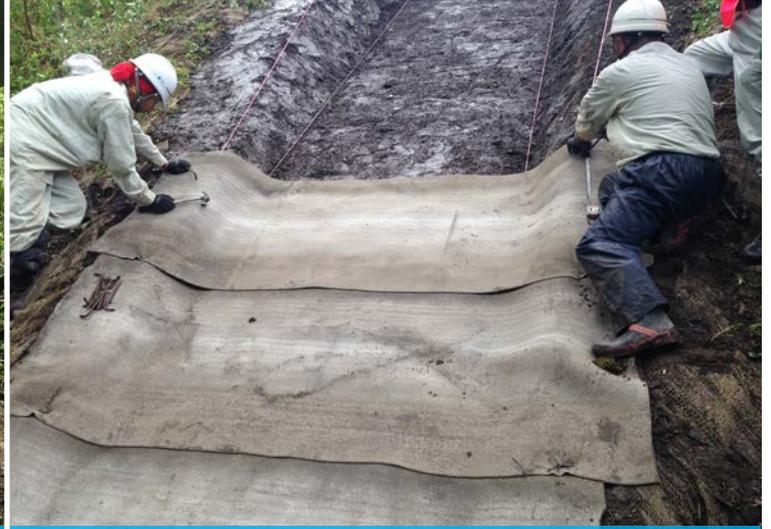
Overlapping the CC

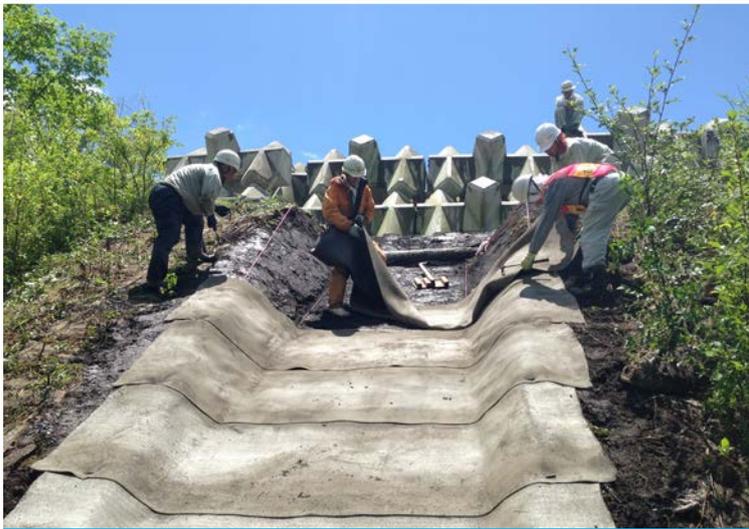
Overlapping the CC

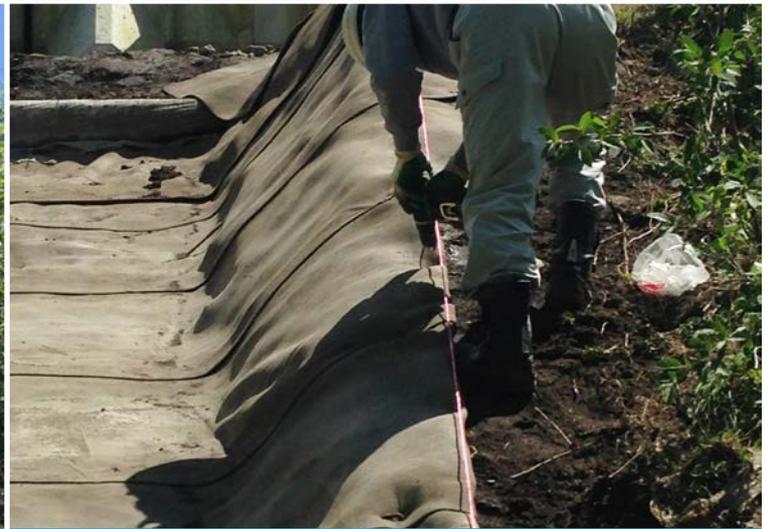
Edge treatment

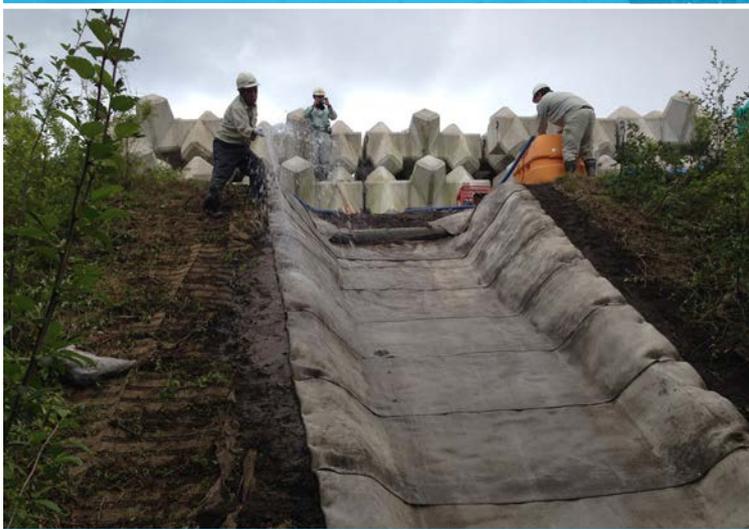
Hydration

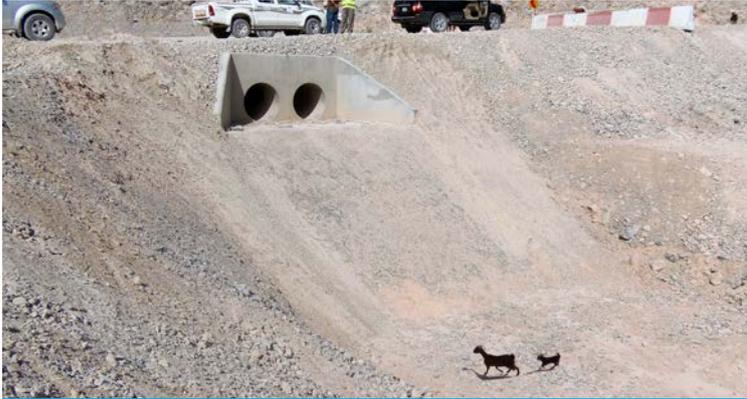
Graded slope beneath culvert

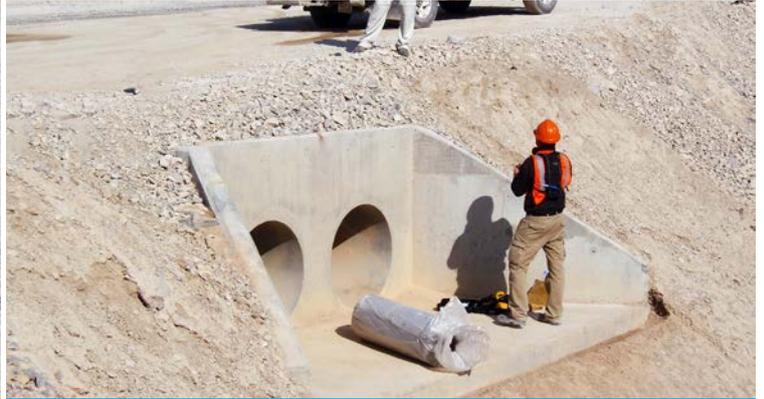
Batched rolls of CC13™ were used

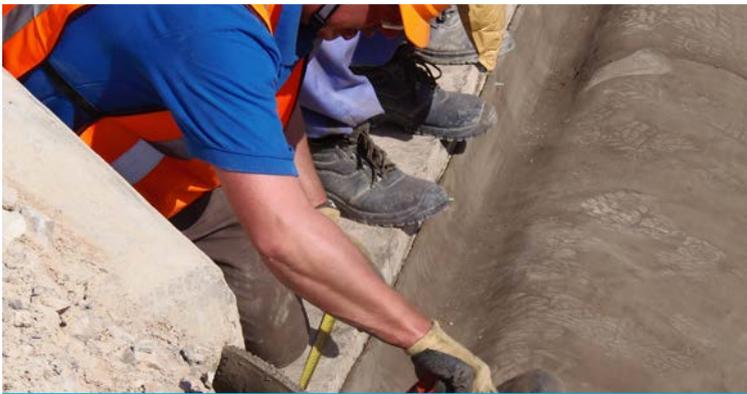
The uppermost most CC layer was Hilti nailed to the top lip

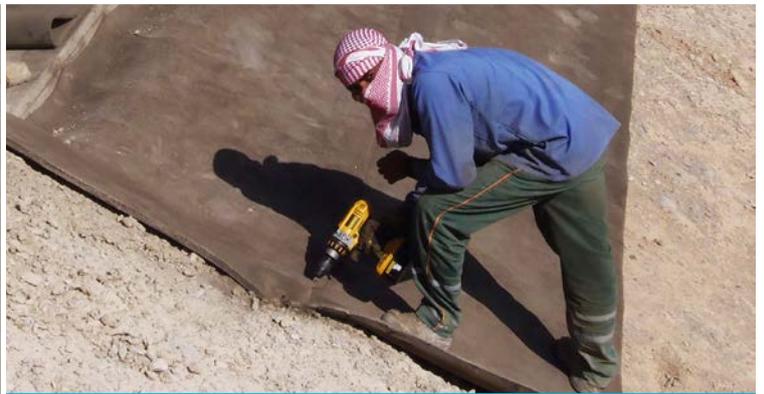
Subsequent CC layers were screwed together

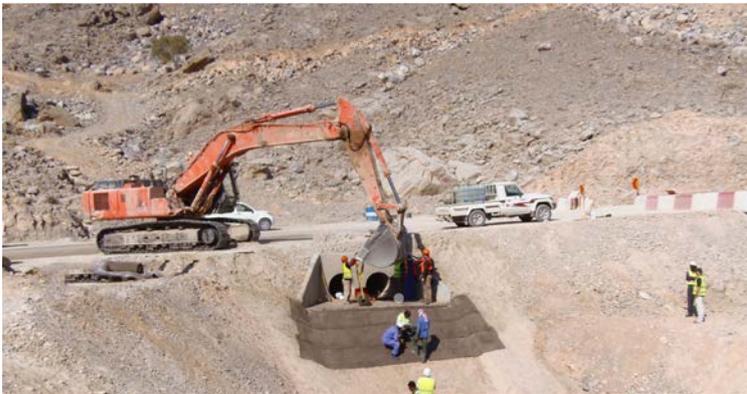
CC13™ batched rolls being craned into position from road access

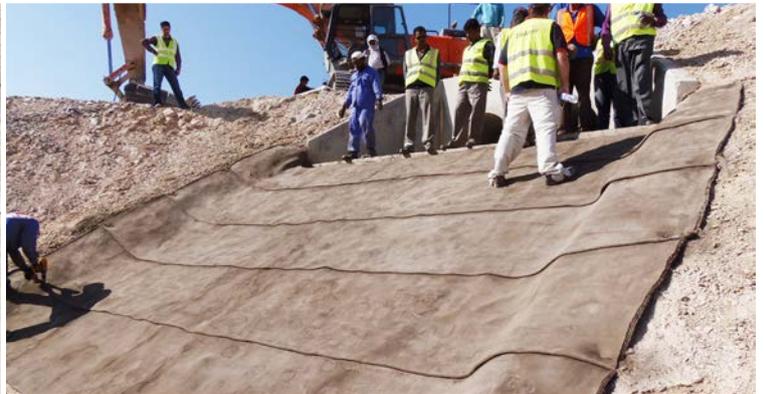
5 CC layers were installed in total

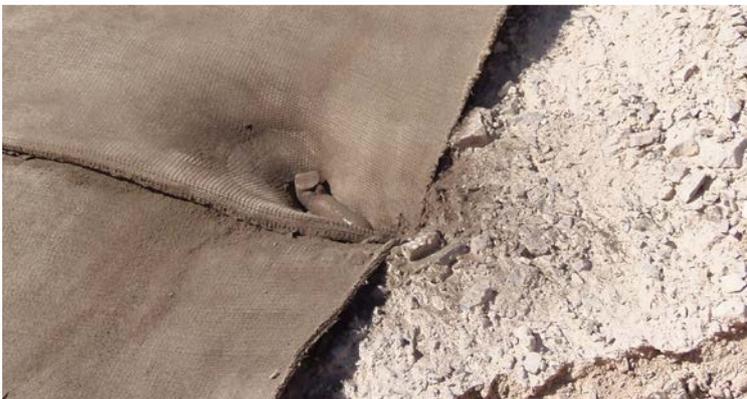
CC layer edges were fixed with ground pegs at overlapping joints

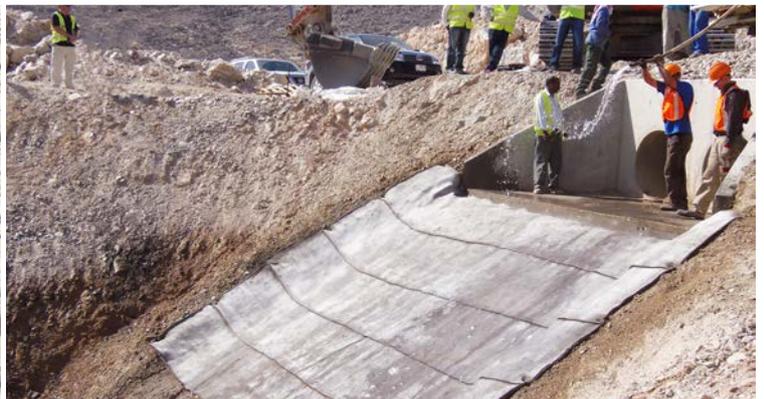
Once installed, the CC layers were hydrated from a bowser

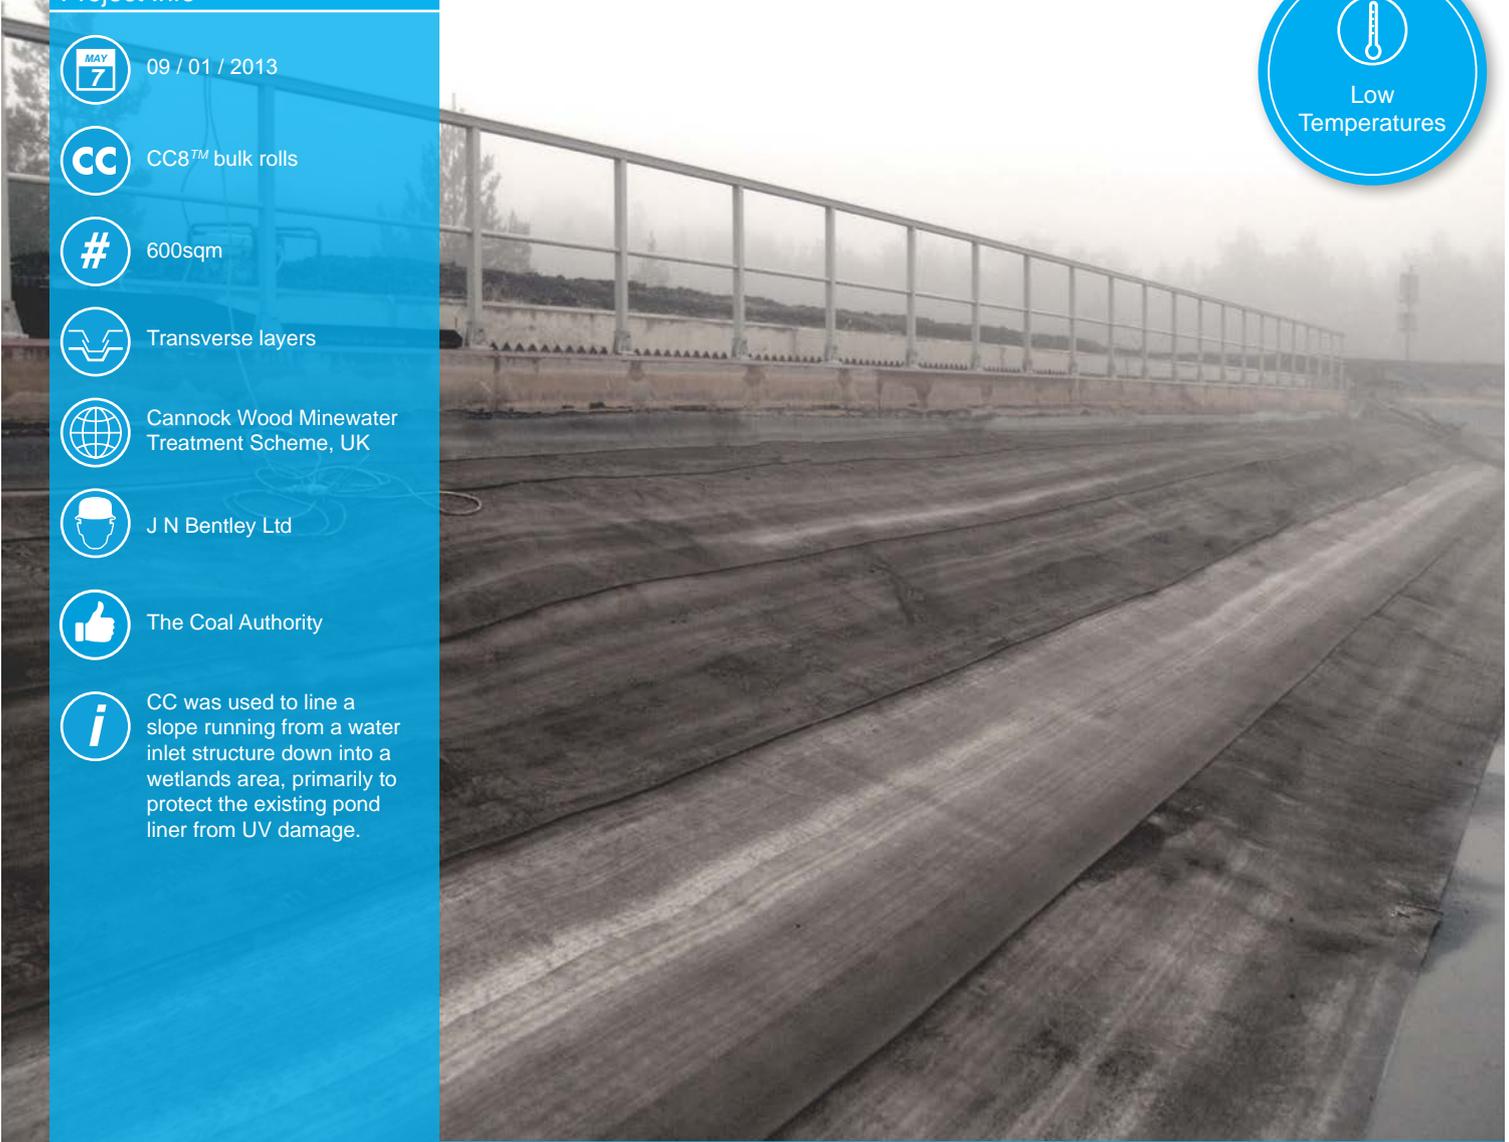
Completed spillway

CC8™ was installed in transverse layers, starting at the base of the slope, using a Komatsu 210 excavator and spreader beam equipment. The first layer was fixed directly to the existing pond liner using CT1 adhesive, with subsequent layers overlapped by approximately 100mm in the direction of water flow and fixed in the same way. At the top of the slope, CC was fixed to the inlet structure using a combination of CT1 adhesive, hammer screws and a length of GRP batten, helping to prevent water ingress. Hydration was achieved by flooding the weir from an adjacent pond and letting it run over onto the CC.

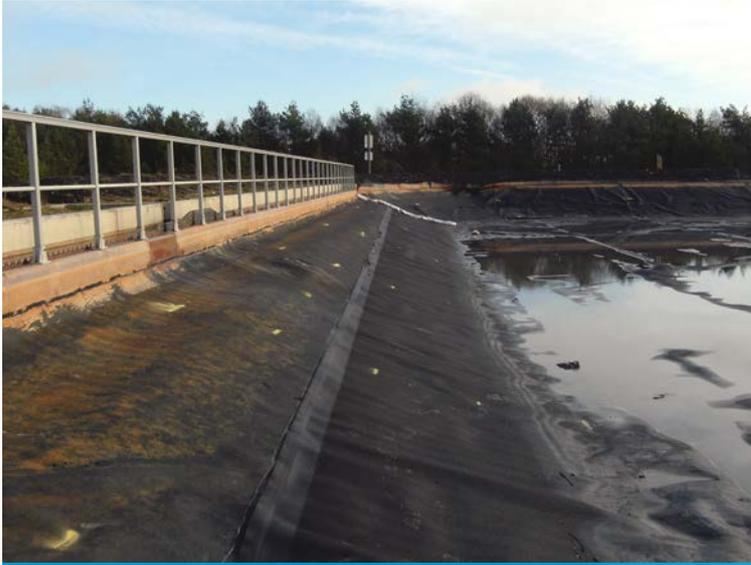
Spillway prior to installation of CC

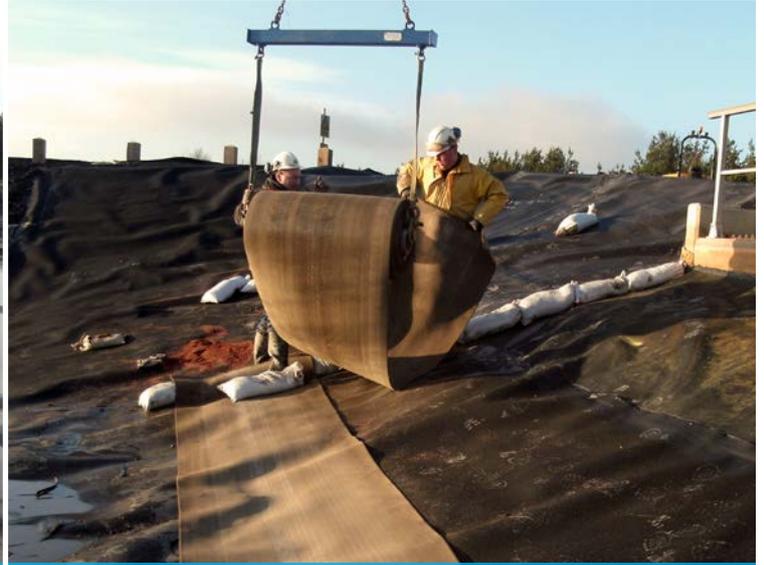
CC bulk rolls deployed from excavator using spreader beam

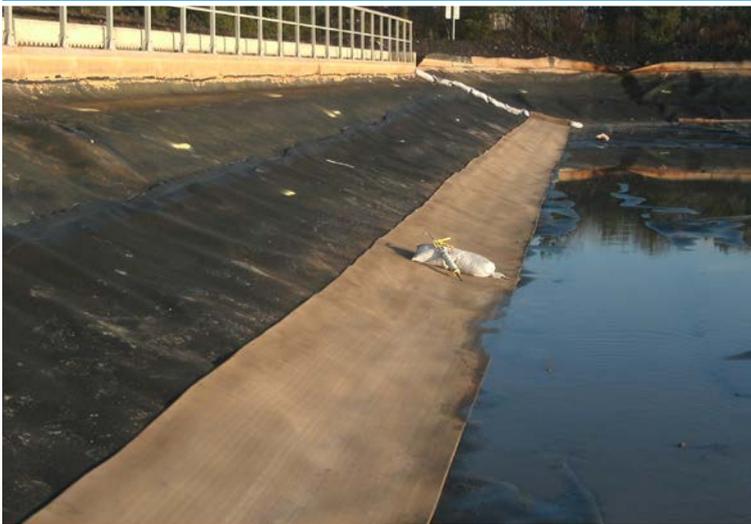
First layer of CC cut to length on site and fixed with CT1 adhesive

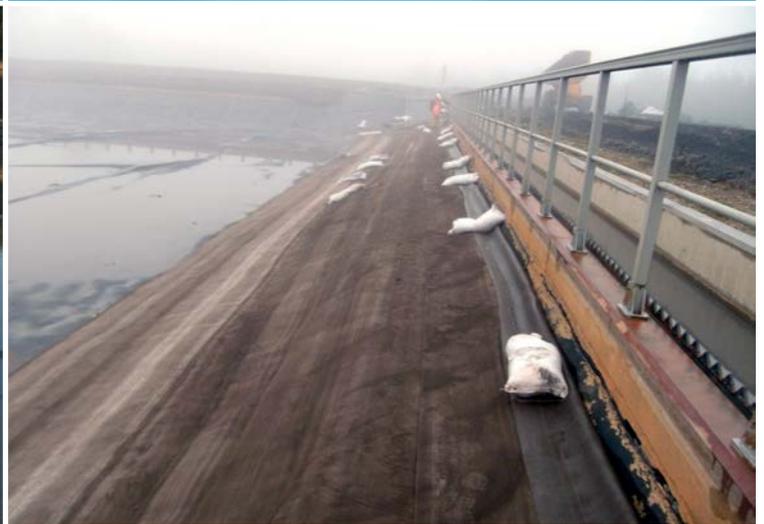
Adjacent layers of CC overlapped by approx. 100mm and fixed with CT1

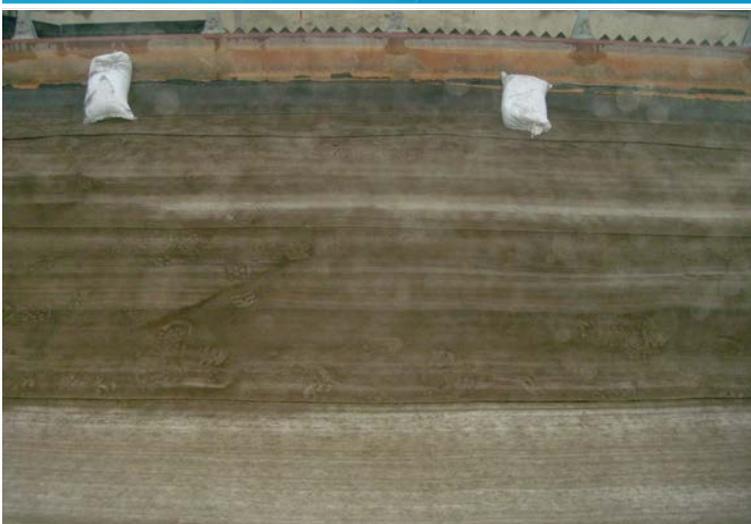
Hydration achieved by flooding adjacent pond, allowing it to spill over CC

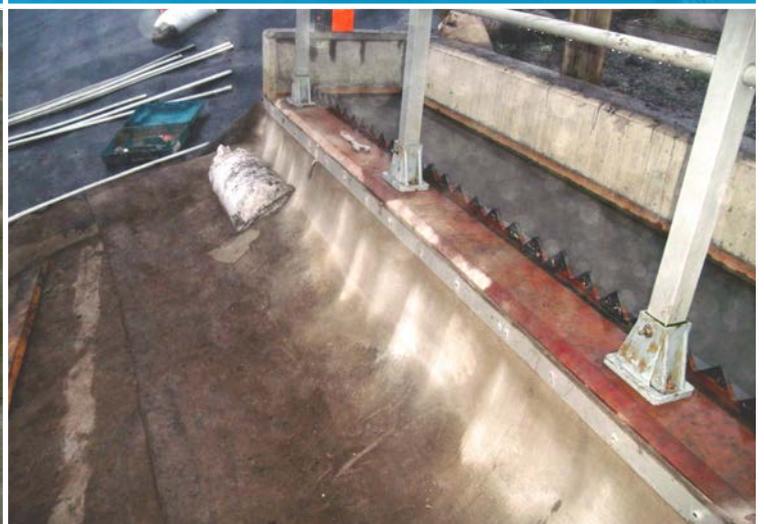
CC fixed to inlet structure using CT1, hammer screws and GRP batten
