Petroineos Pipe Track Remediation,
Petroineos Grangemouth Refinery

CC used as weed
suppression under
complex series of pipe
tracks at Grangemouth
Refinery

Overton Road Pipetrack Remediation Phase 3

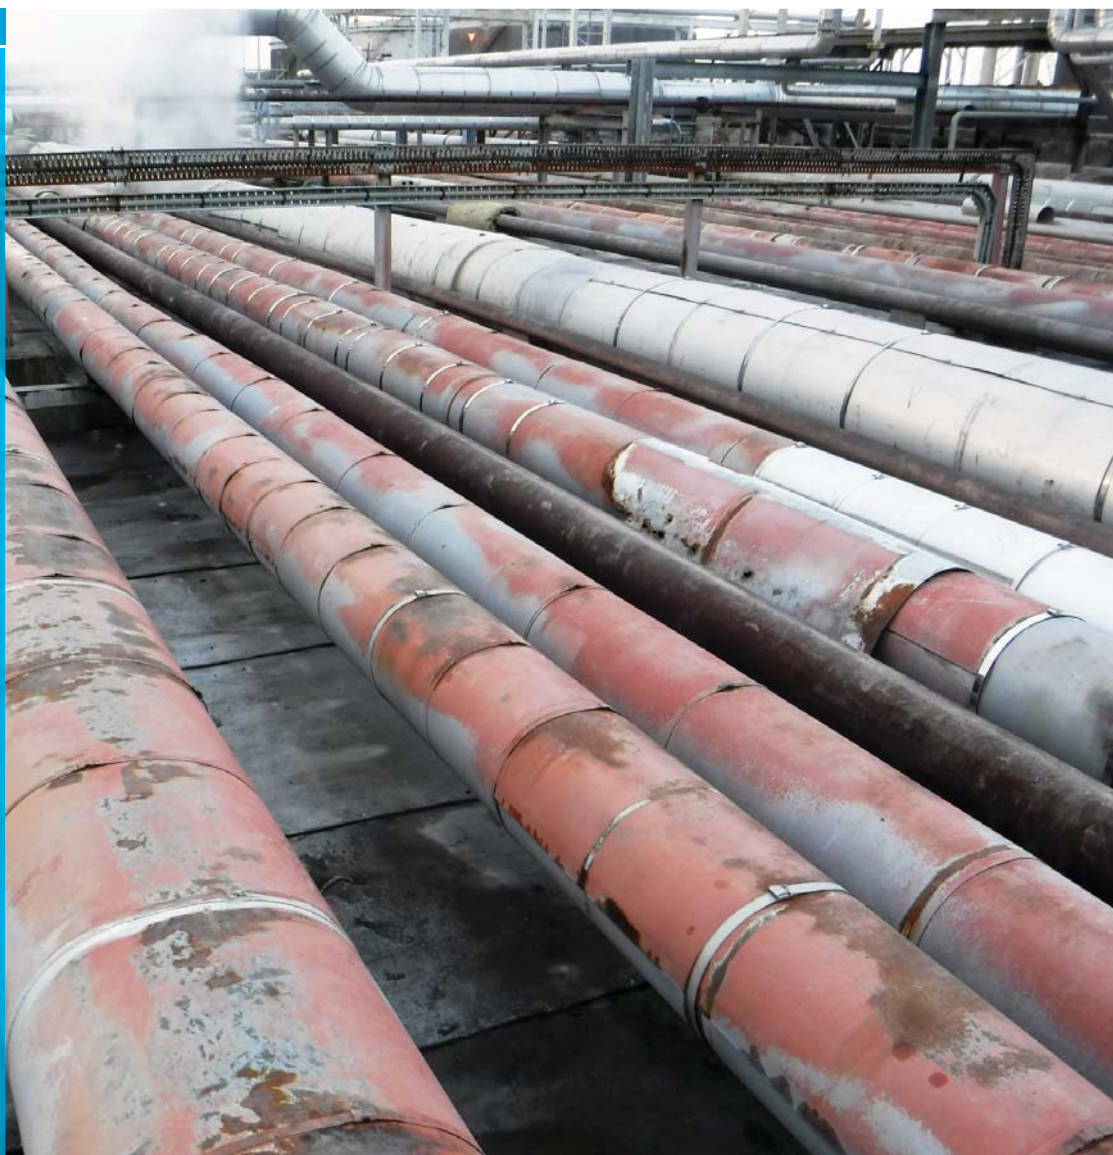
Completed CC lined pipe track.

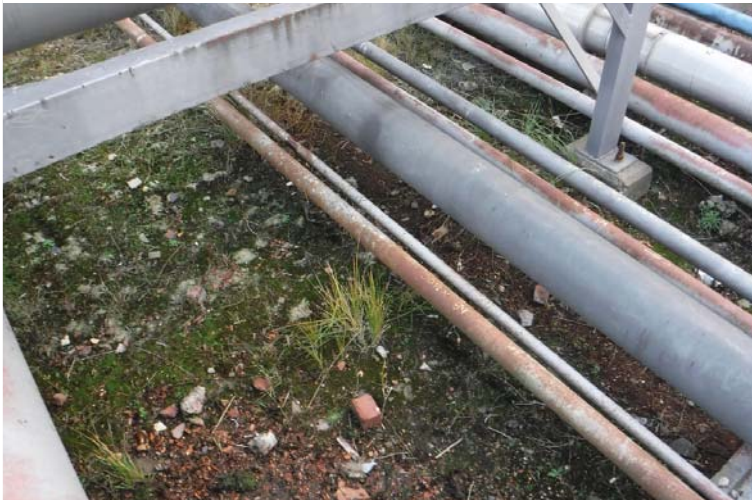
Site prior to clearance and showing vegetation growth.

Prior to deploying the Concrete Canvas®, the pipe track area was first graded, made as even as was practical and any vegetation growth removed. Given the low profile and restricted clearance levels between the pipes and the track floor, the CC was deployed where possible using a modified light weight spreader beam to pull the material in lengths under the pipework.

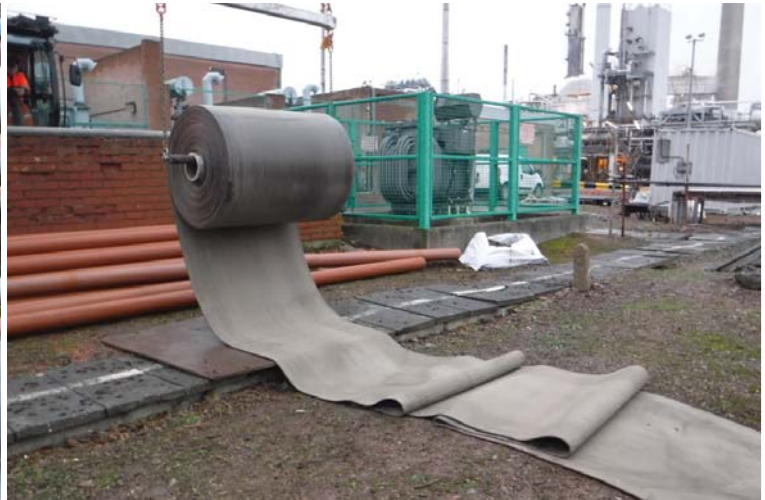
Dispensing of bulk roll CC8 via spreader beam.

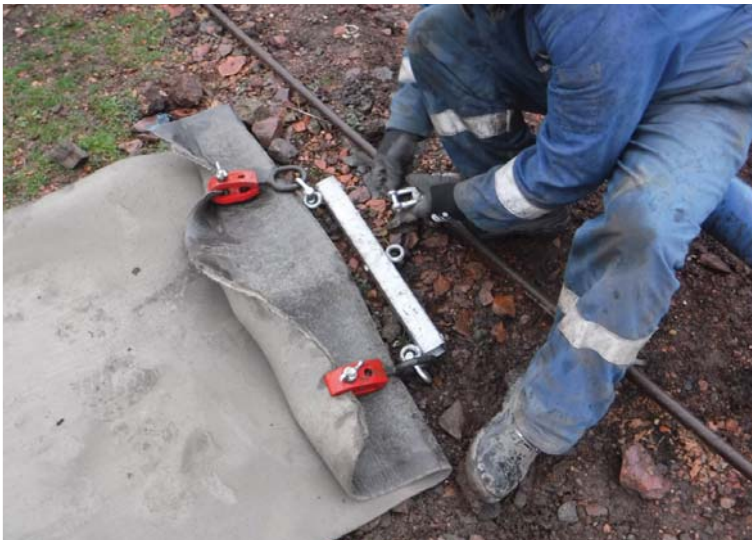
Attachment of low profile pulling jig.

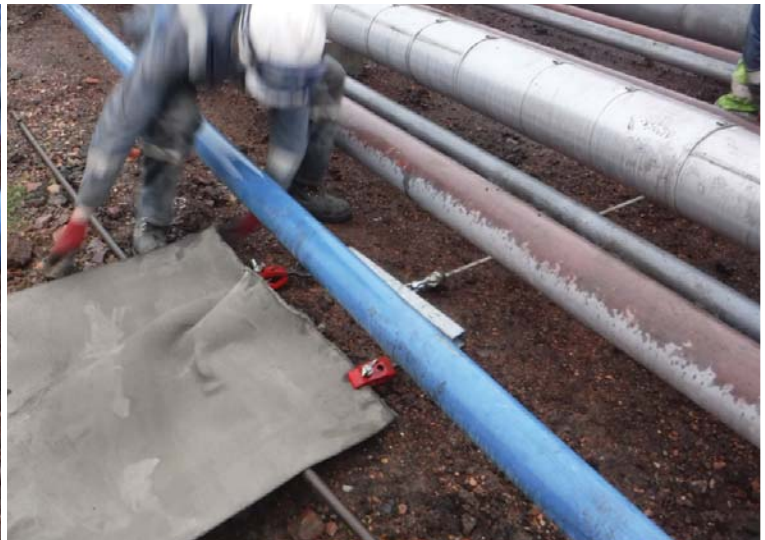
Feeding of CC8 under low profile.

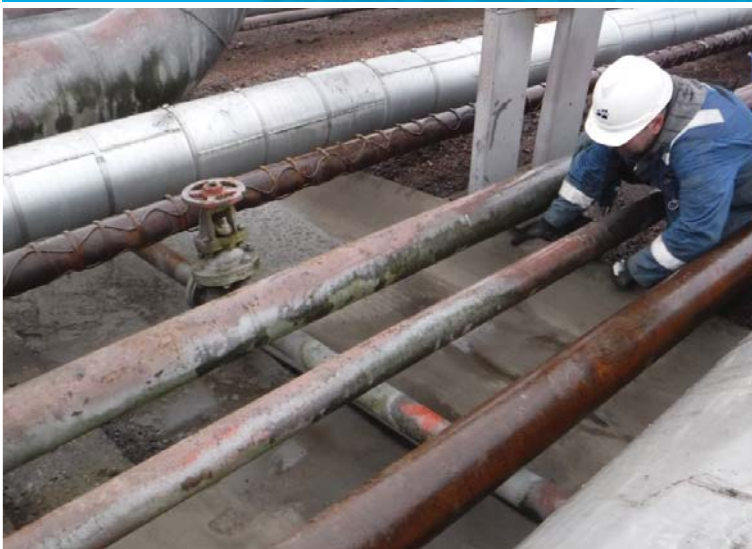
Adjusting position to create 100mm overlaps prior to screwing joint.

The CC layers were laid perpendicular to the pipe track to accommodate the majority of pipe upstands and to minimise the length and subsequent weight of each individual layer. Subsequent layers were overlapped by 100mm and screwed together using SS 35mm screws at 200mm centres through the overlap. The material was actively hydrated using the onsite water mains.

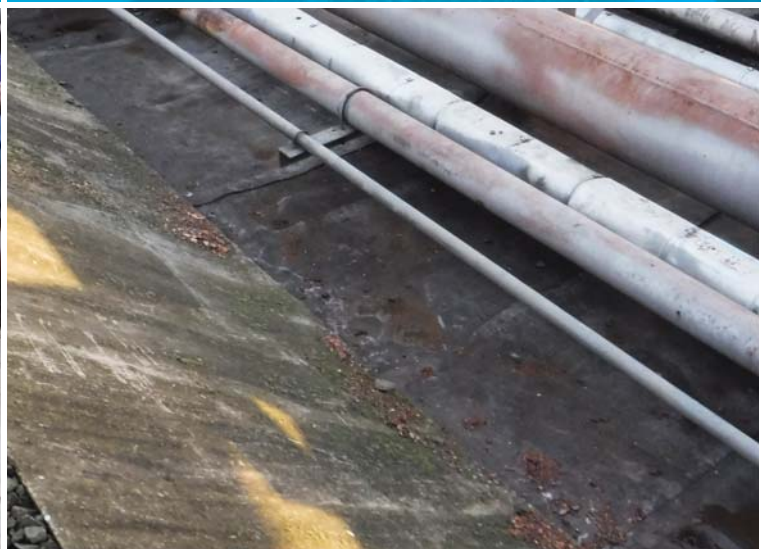
CC8 terminations to existing concrete infrastructure.

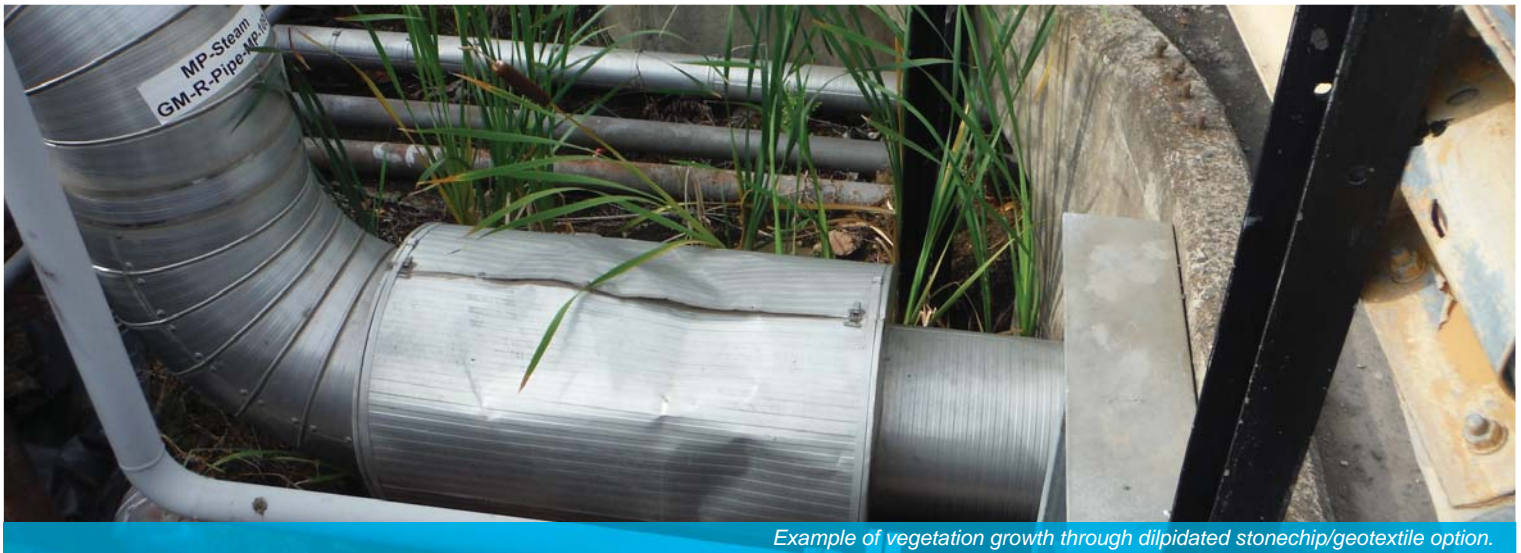
Example of vegetation growth through dilapidated stonechip/geotextile option.

Stone chips are the traditional method for dressing pipe track floors due to the relatively lower cost of installation compared to conventional poured concrete floors. However, it has been demonstrated that over time, dirt will build up within the stone chips which would allow root vegetation to grow (as observed in previous phase of the Overton Rd. pipe track remediation project). Stone chips also do not prevent the burrowing of animal and wildlife into what can be sensitive infrastructure. Stone chips also hide pooling of water and hydrocarbons.
