Bulk CC8 and CC13

British Columbia,
Canada

British Columbia Ditch Lining cont.

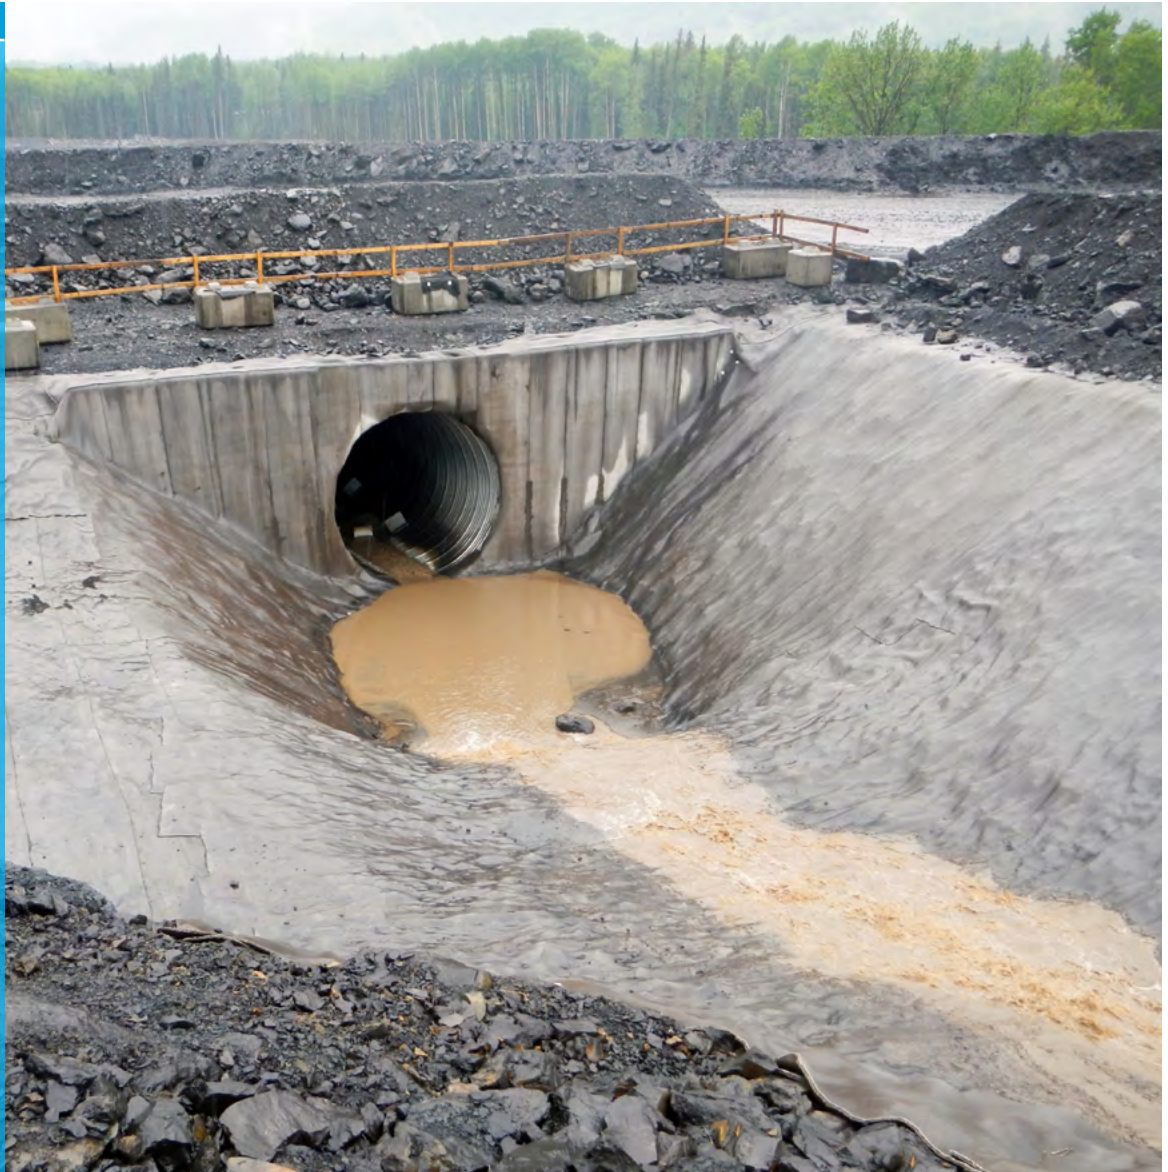
Completed lined ditch channel and culvert.

The ditch terminated in a 4m diameter corrugated steel and concrete block work culvert and sump which was also lined with CC to ensure minimum water loss, as water was contaminated from tailings and could not come into contact with any other water sources.

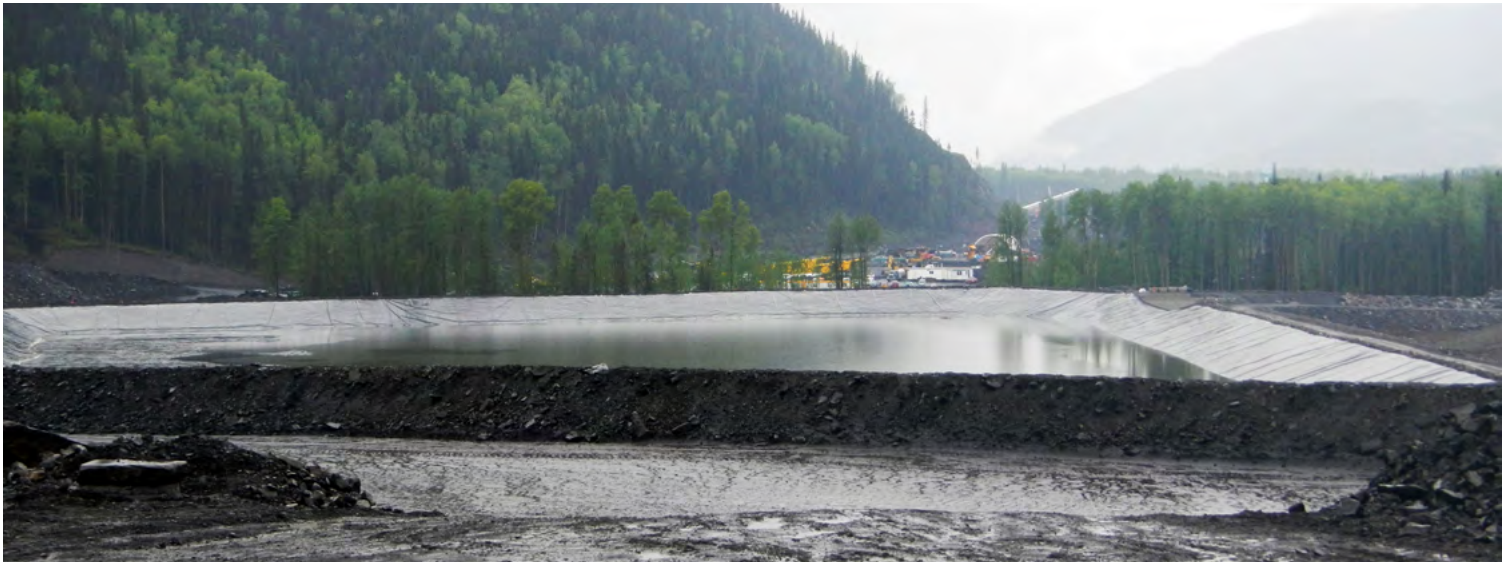
Large settling pond collecting effluent from nearby Willow Creek coal mine, British Columbia, Canada

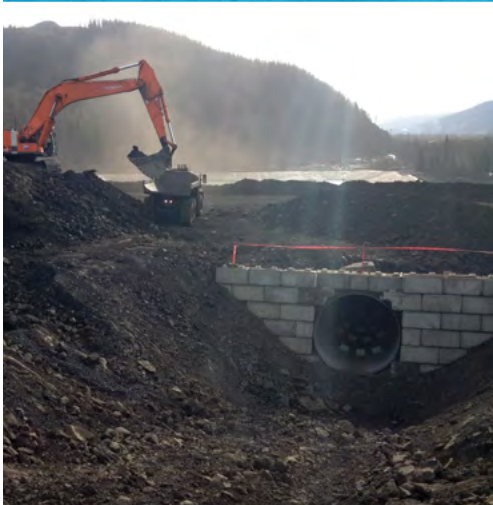
Excavating the sump and constructing the culvert

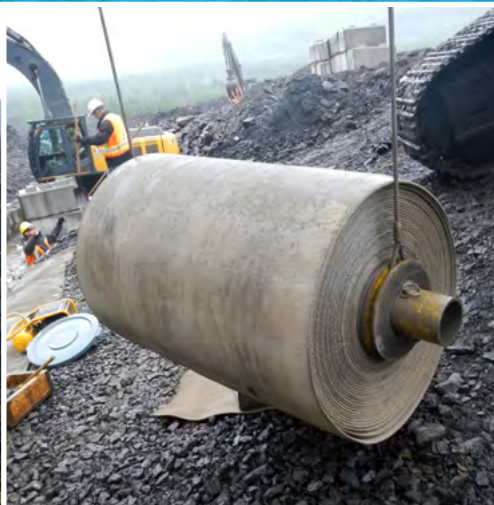
CC dispensed from bulk rolls

CC was dispensed in bulk rolls from spreader beam equipment and was cut to length on site, minimising waste as lengths were cut specifically to each section of profile. No perishable formwork or additional reinforcement was required.

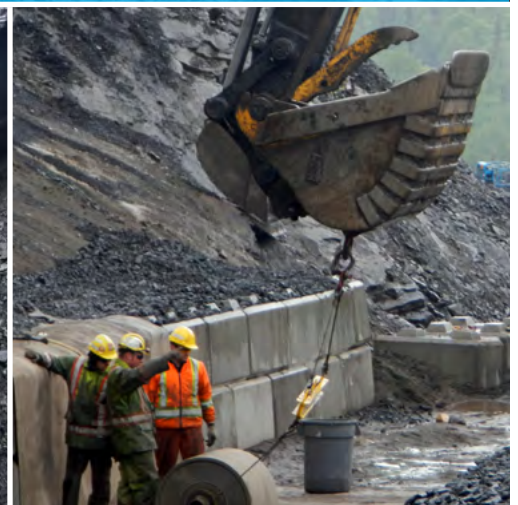
Using plant to unroll CC bulk rolls across channel

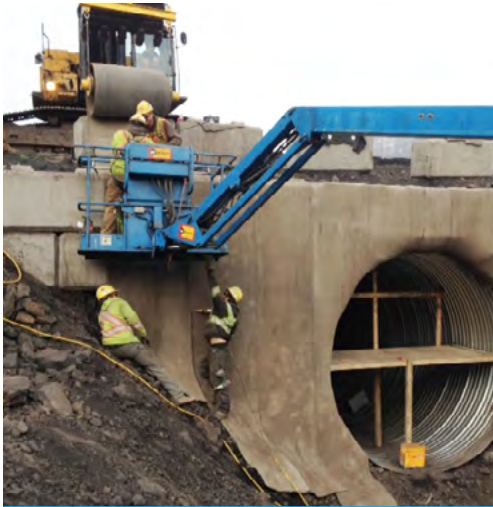
Lining the culvert with CC8

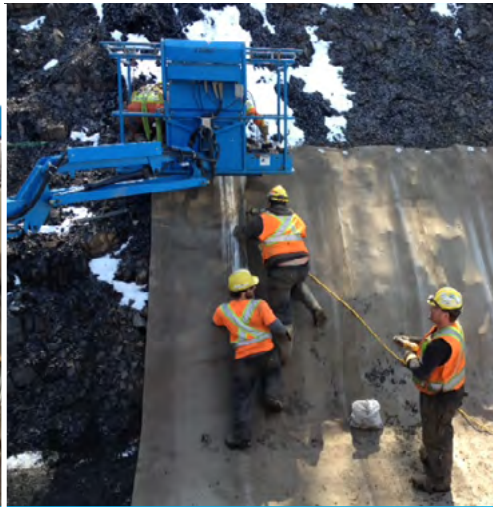
Applying Sikaflex beading to joints

CC layers were laid transversely across the width of the ditch, with adjacent layers overlapped by 100mm and beaded with Sikaflex 1A to create water tight joints. Overlaps were fixed together using 25mm screws for neatness and flushness. Where possible, end edges were buried with loose shale and aggregate to prevent water ingress under the CC and to provide a neat seamless termination with the crest of the ditch.

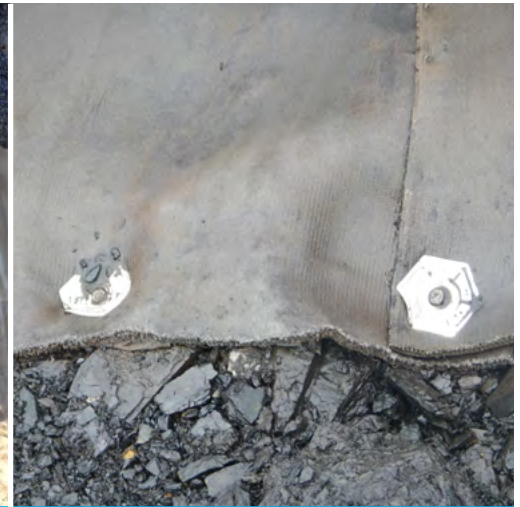
6" steel anchor nails with 1" hex head washers

The ditch was excavated from a blasted rock substrate, with some sections reinforced with concrete block work. CC layers were pinned into position at the top of the profile using 10" Ardox galvanized spikes. When fixing CC to the concrete block work sections, Hilti rock anchors were used. In its unset flexible state prior to hydration, CC can be fixed to almost every type of substrate using standard off-the-shelf fixings or adhesives.

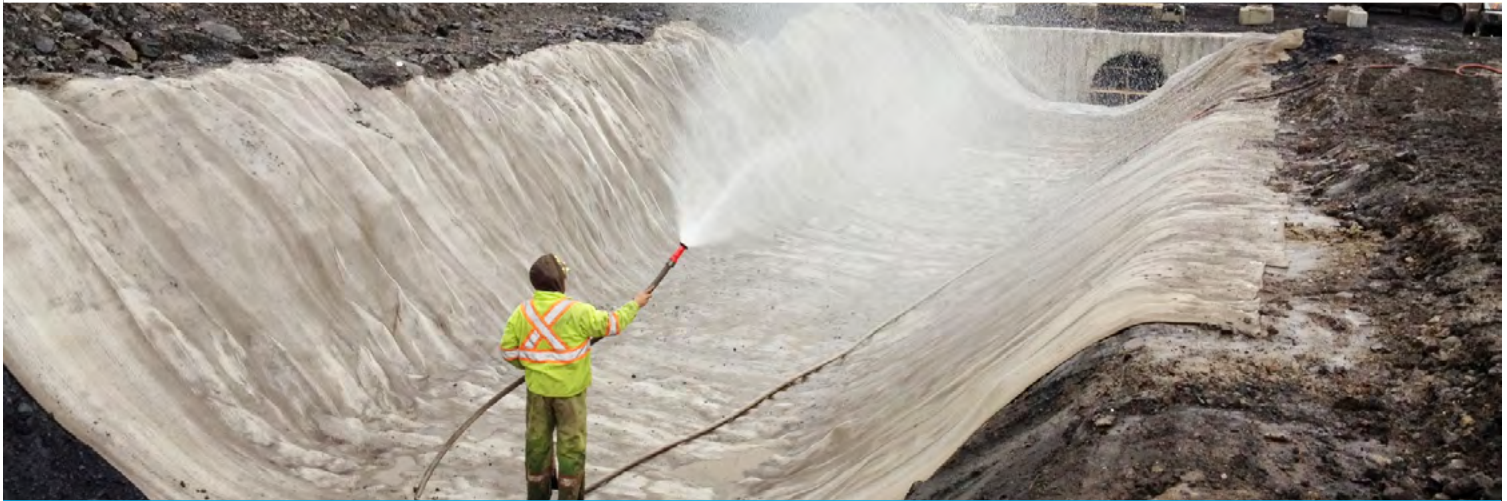
Hydration of CC using bowser equipment

CC has a working time of approximately two hours from hydration, meaning that work can continue in very wet conditions. This can reduce programme disruption typically caused by bad weather when using traditional concrete solutions. Plastic sheeting was used to protect the CC during setting when temperatures dropped to below -5°C.

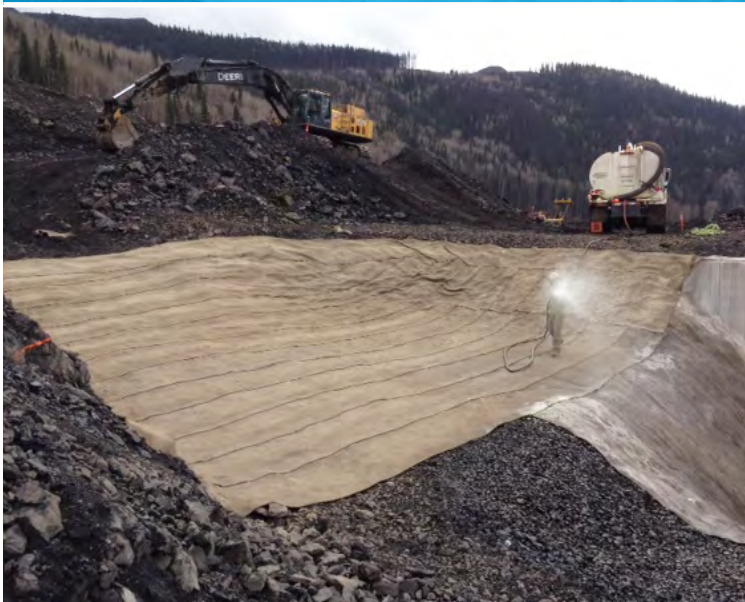
Swale was formed on the north ridge of the ditch at a nearby tree line to collect surface rainfall from an adjacent hillside.

A swale was formed on the north ridge of the ditch at a nearby tree line to collect surface rainfall from an adjacent hillside, using the ability of CC to closely follow the profile of existing slopes and negotiate tight bends and curvatures.

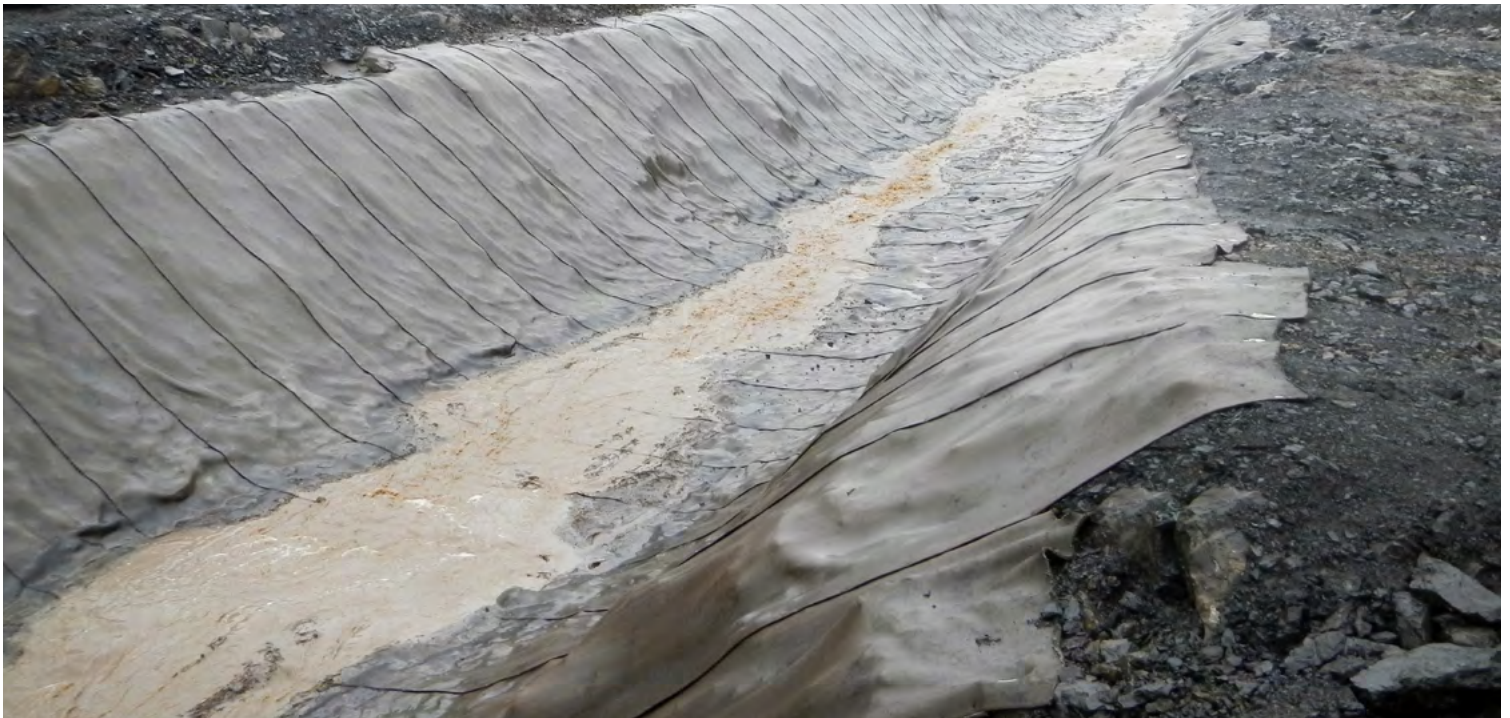
Completed lined ditch channel
